GROUP 42A

BODY

BODY HOOD

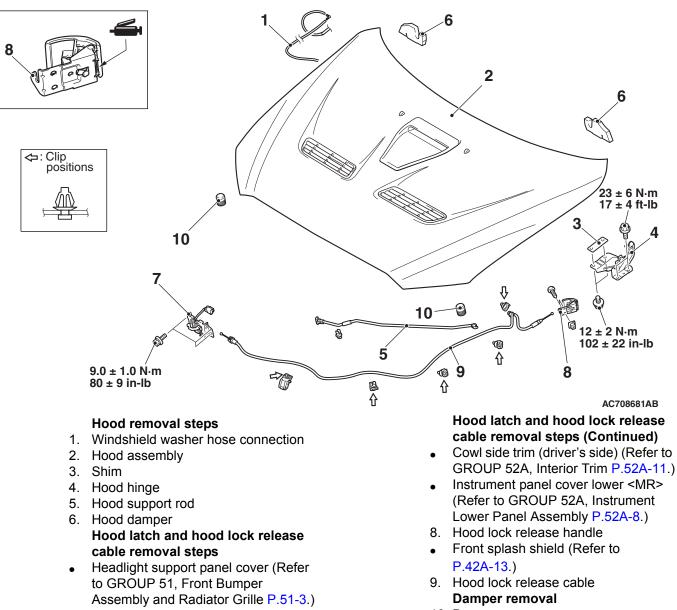
7. Hood latch

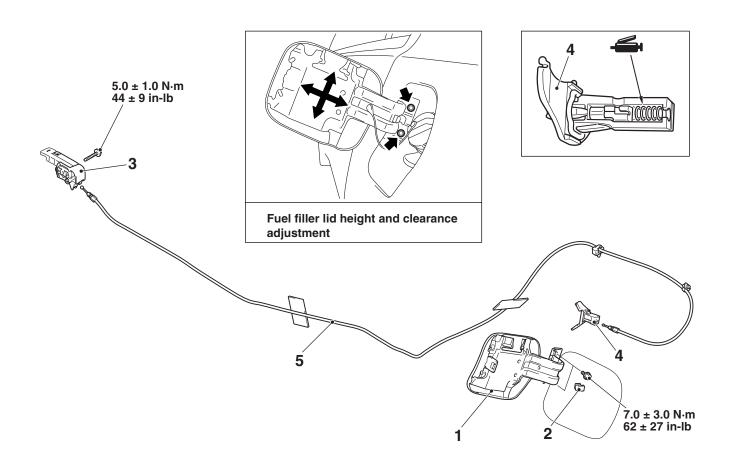
Fuel filler lid removal steps

- 1. Fuel filler lid
- 2. Fuel filler lid damper spring Fuel filler lid lock release cable removal steps
- Front scuff plate <Driver's side> (Refer to GROUP 52A, Interior Trim P.52A-11.)
- 3. Fuel filler lid lock release handle
- Trunk side trim <LH> (Refer to GROUP 52A, Interior Trim P.52A-11.)
- 4. Fuel filler lid hook

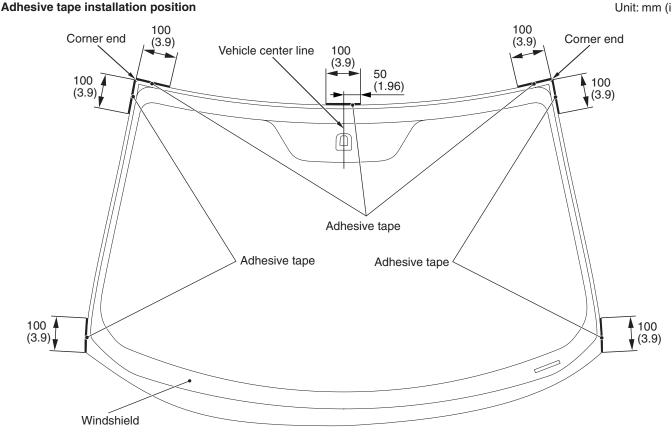
AC608860AB 3. Install the adhesive tape to the windshield.

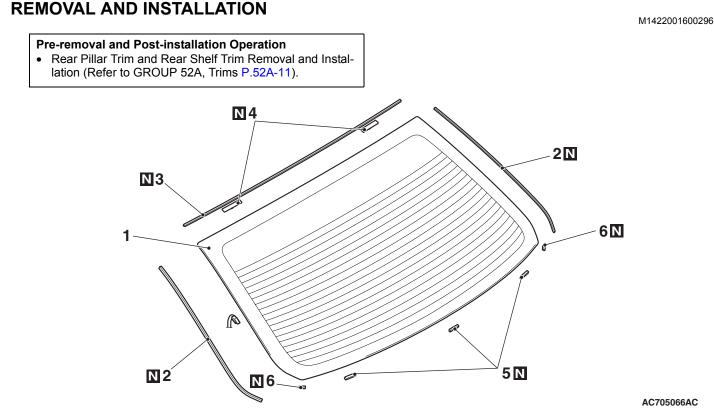
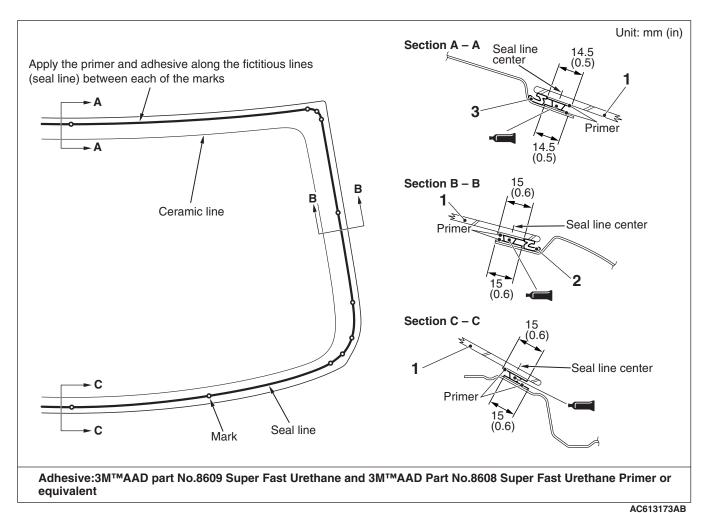
REMOVAL STEPS

- Harness connector
- <<A>> >>B<< 1. Rear window glass
 - >>**A**<< 2. Rear window side dam

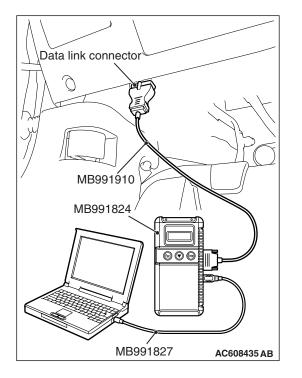
STEP 2. Using scan tool MB991958, read the diagnostic trouble code.

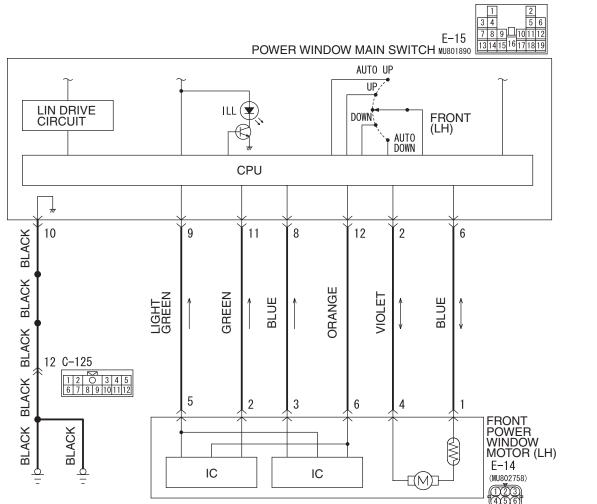
Connectors: E-14, E-15

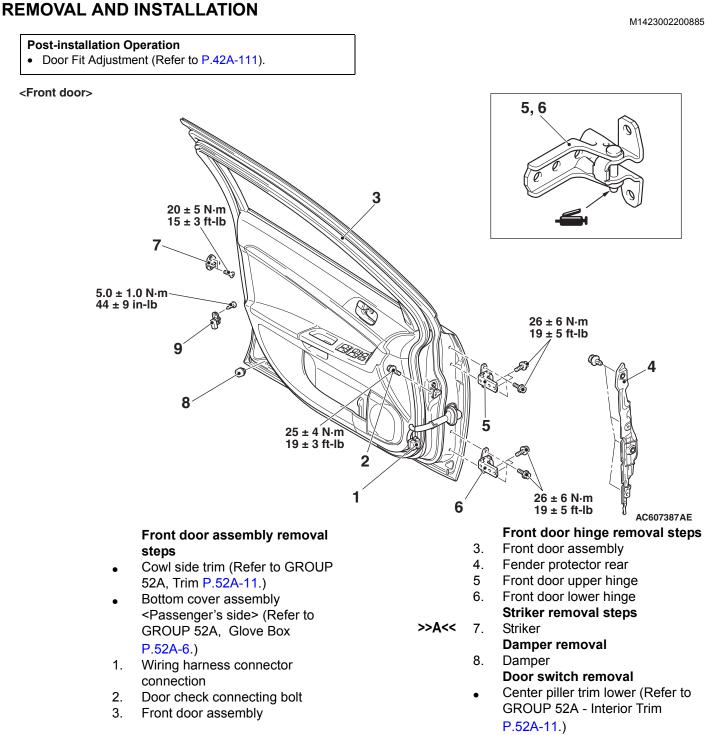
9. Door switch

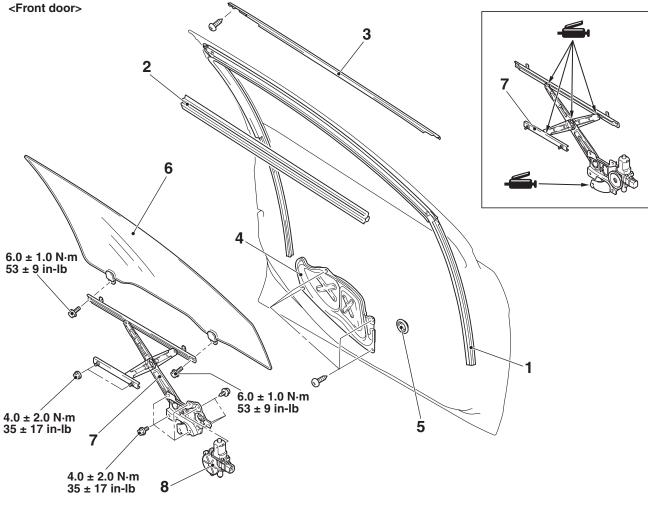
Door window glass assembly removal steps

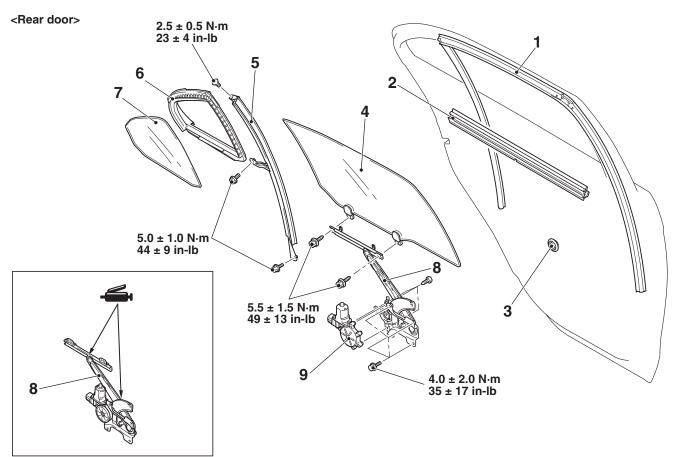
Power window regulator removal steps

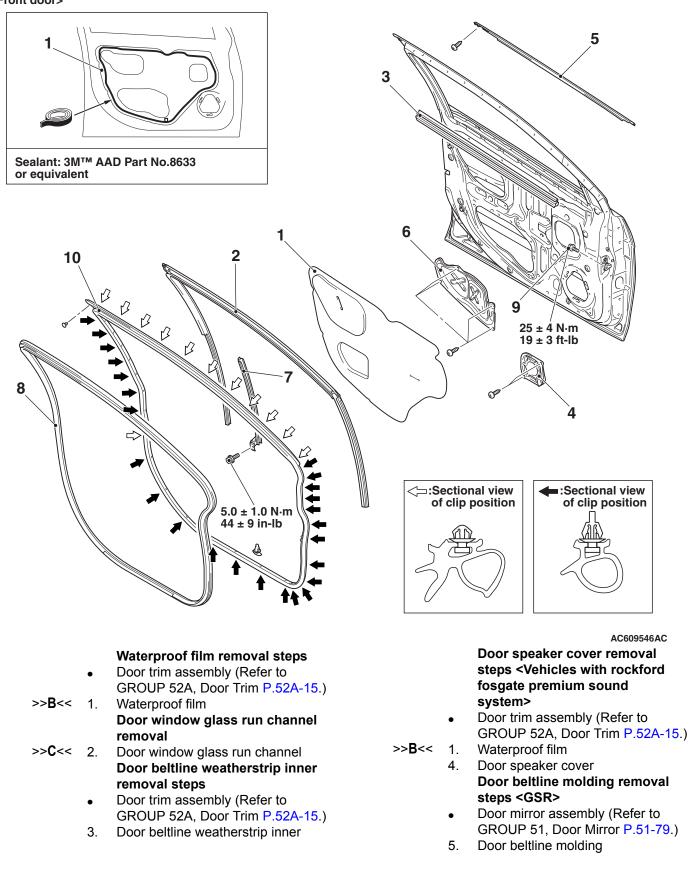
Door beltline molding removal
			steps <mr></mr>
		•	Door mirror assembly (Refer to
			GROUP 51, Door Mirror P.51-79.)
		•	Door trim assembly (Refer to
	>> D / /	4	GROUP 52A, Door Trim P.52A-15.)
	>>B<<	1.	Waterproof film

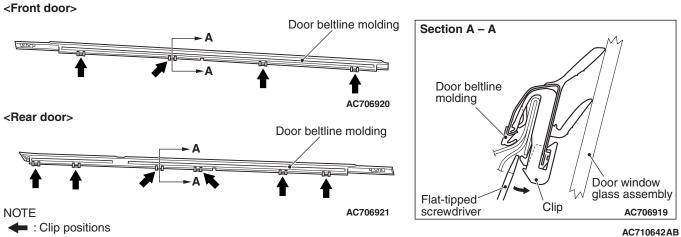
<<A>> DOOR BELTLINE MOLDING REMOVAL

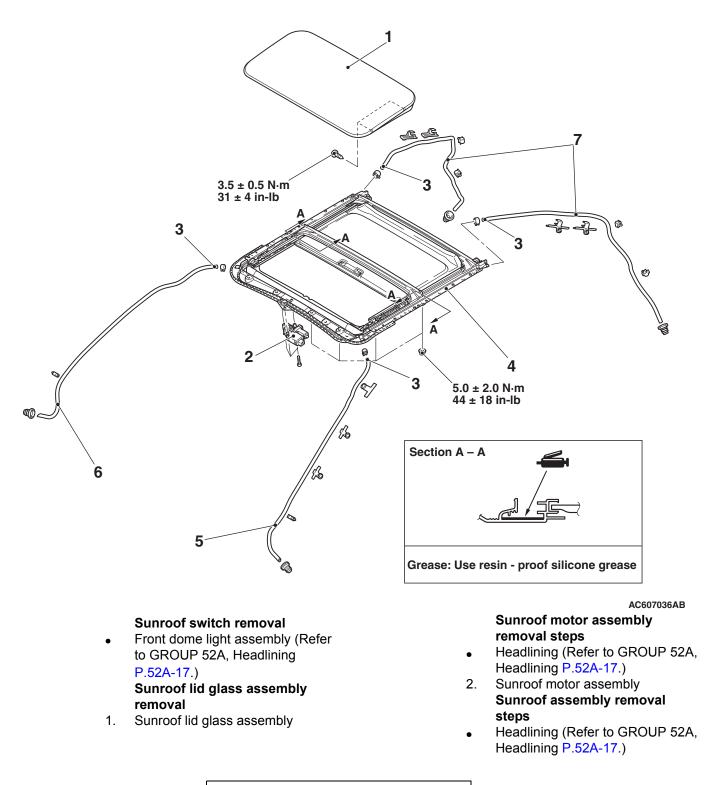
Sunroof assembly removal steps (Continued)

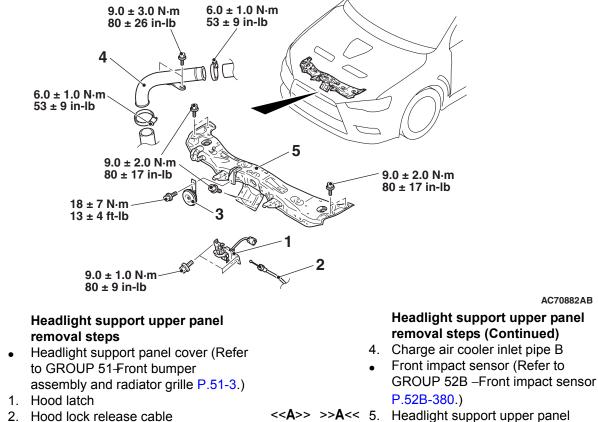
<Headlight support upper panel>

3. Horn (LO)
