GROUP 54B**LOCAL
INTERCONNECT
NETWORK (LIN)****CONTENTS**

GENERAL INFORMATION

LIN refers to "Local Interconnect Network," which is a serial multiplex communication protocol* administered by LIN consortium. A communication circuit employing the LIN protocol connects each ECU, and switch and sensor data can be shared among ECUs, which enables more reduction in wiring.

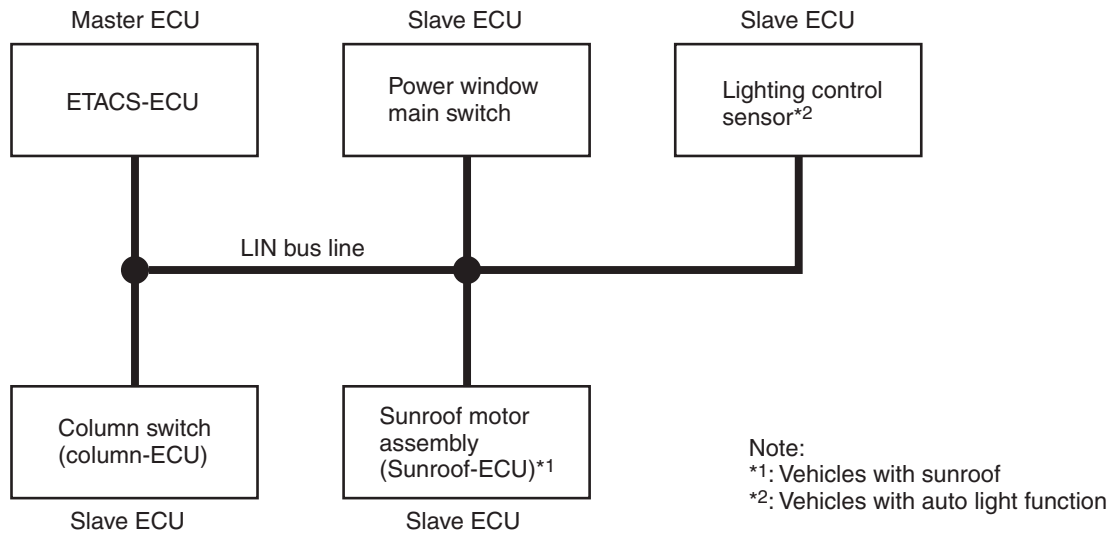
AC708922AB

Master and slave ECUs are connected to the LIN bus lines. The master ECU is the ETACS*¹-ECU, and the slave ECUs are the column switch (column-ECU), the power window main switch, the sunroof-ECU*² and the lighting control sensor*³. The master ECU requests these slave ECUs to communicate each other via communication lines.

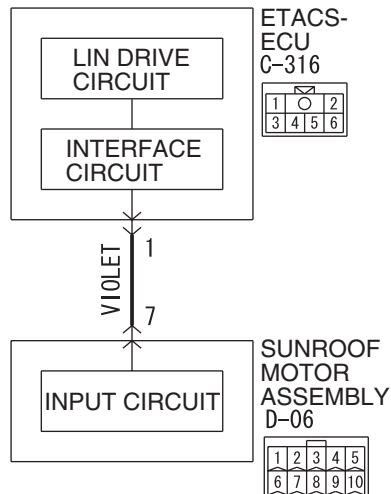
W8G54M182A

Sunroof Motor Assembly LIN Communication Circuit

The ETACS-ECU receives signal from the sunroof motor assembly (sunroof-ECU). If signal cannot be received at all, DTC U0169 will be set.

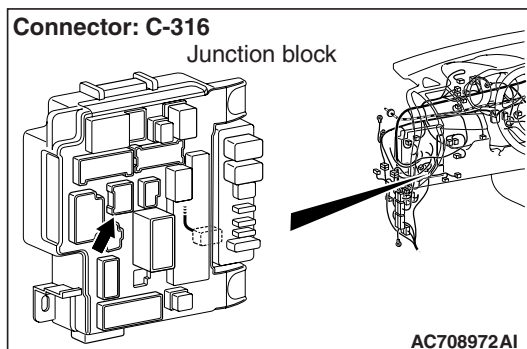
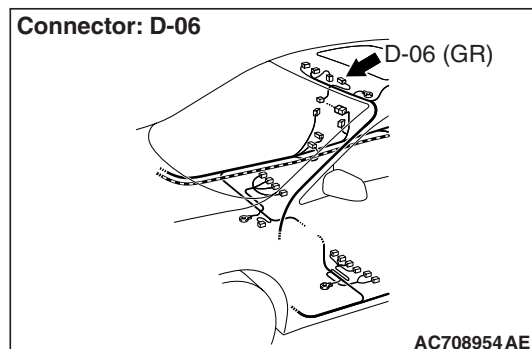
STEP 1. Check ETACS-ECU connector C-316 and sunroof motor assembly connector D-06 for loose, corroded or damaged terminals, or terminals pushed back in the connector.

Q: Is the wiring harness between ETACS-ECU connector C-316 (terminal 1) and sunroof motor assembly connector D-06 (terminal 7) in good condition?

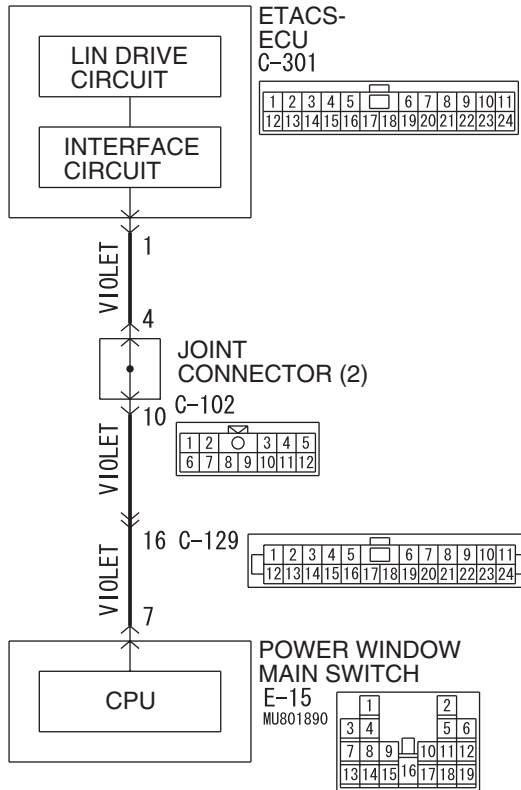
W8G54M183A

Power Window Main Switch LIN Communication Circuit

The ETACS-ECU receives signal from the power window main switch. If signal cannot be received at all, DTC U0215 will be set.

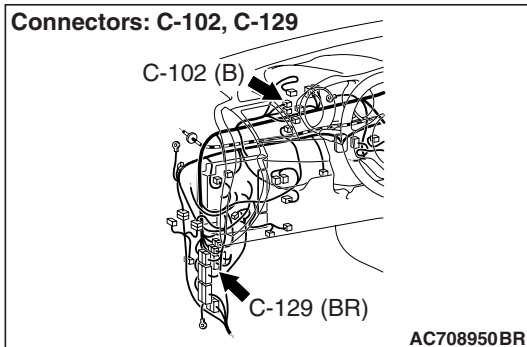
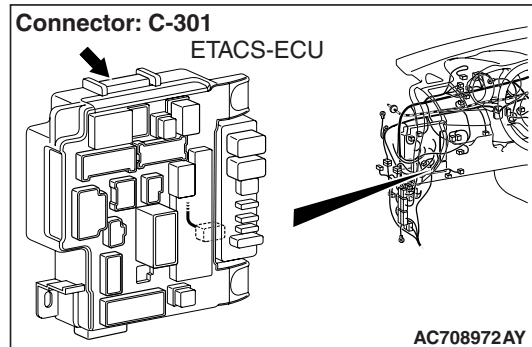
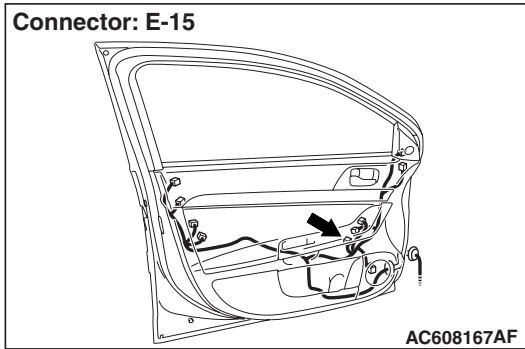
STEP 1. Check ETACS-ECU connector C-301 and power window main switch connector E-15 for loose, corroded or damaged terminals, or terminals pushed back in the connector.

Q: Is the wiring harness between ETACS-ECU connector C-301 (terminal 1) and power window main switch connector E-15 (terminal 7) in good condition?

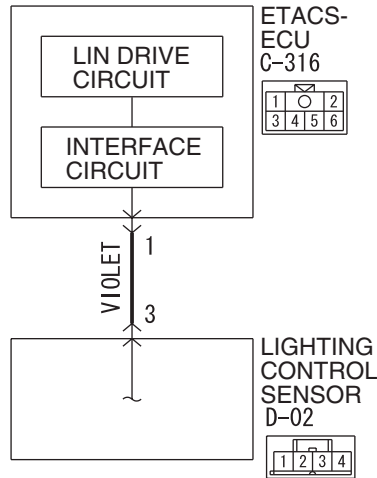
W8G54M184A

Lighting Control Sensor LIN Communication Circuit

The ETACS-ECU receives signal from the lighting control sensor. If signal cannot be received at all, DTC U0231 will be set.

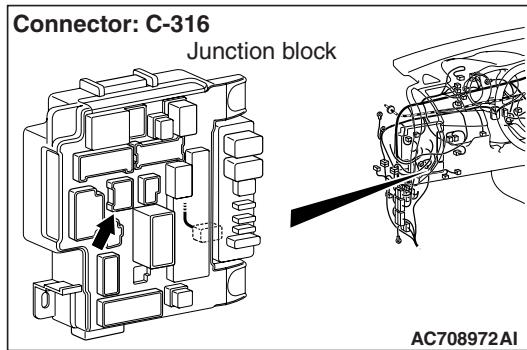
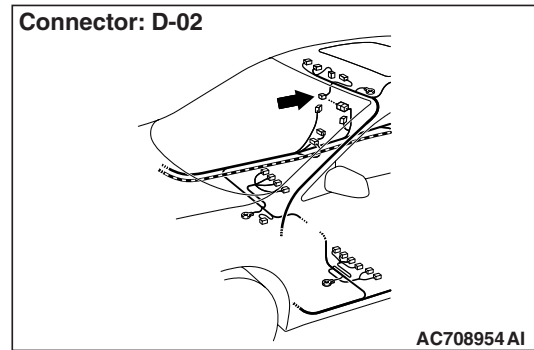
STEP 1. Check ETACS-ECU connector C-316 and lighting control sensor connector D-02 for loose, corroded or damaged terminals, or terminals pushed back in the connector.

Q: Is the wiring harness between ETACS-ECU connector C-316 (terminal 1) and lighting control sensor connector D-02 (terminal 3) in good condition?

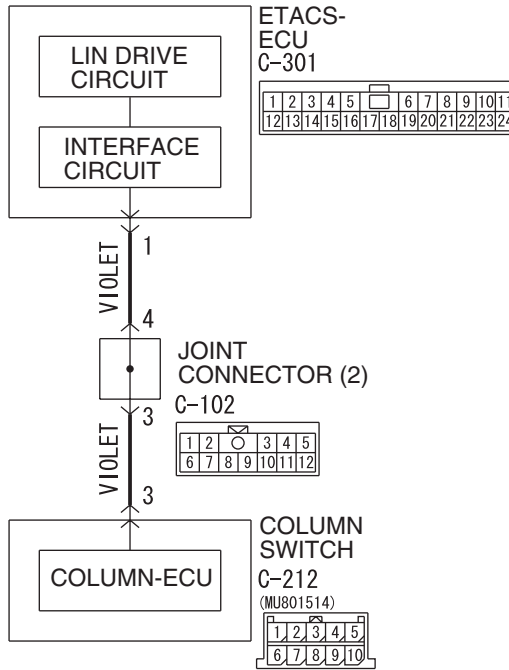
W8G54M185A

Column Switch LIN Communication Circuit

The ETACS-ECU receives signal from the column switch. If signal cannot be received at all, DTC U1109 will be set.

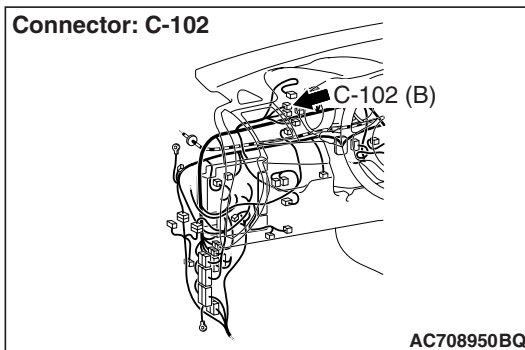
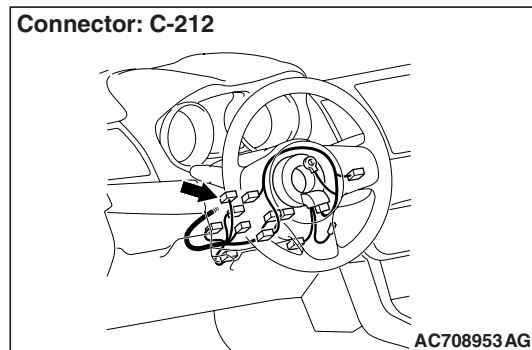
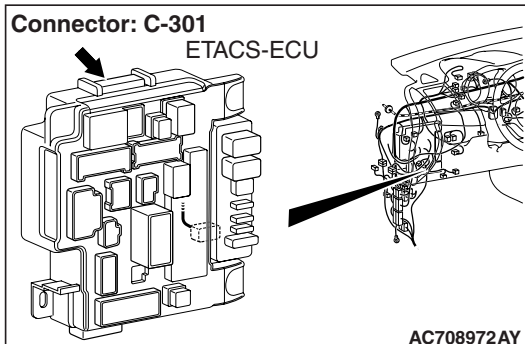
STEP 1. Check ETACS-ECU connector C-301 and column switch connector C-212 for loose, corroded or damaged terminals, or terminals pushed back in the connector.

Q: Is the wiring harness between ETACS-ECU connector C-301 (terminal 1) and column switch connector C-212 (terminal 3) in good condition?

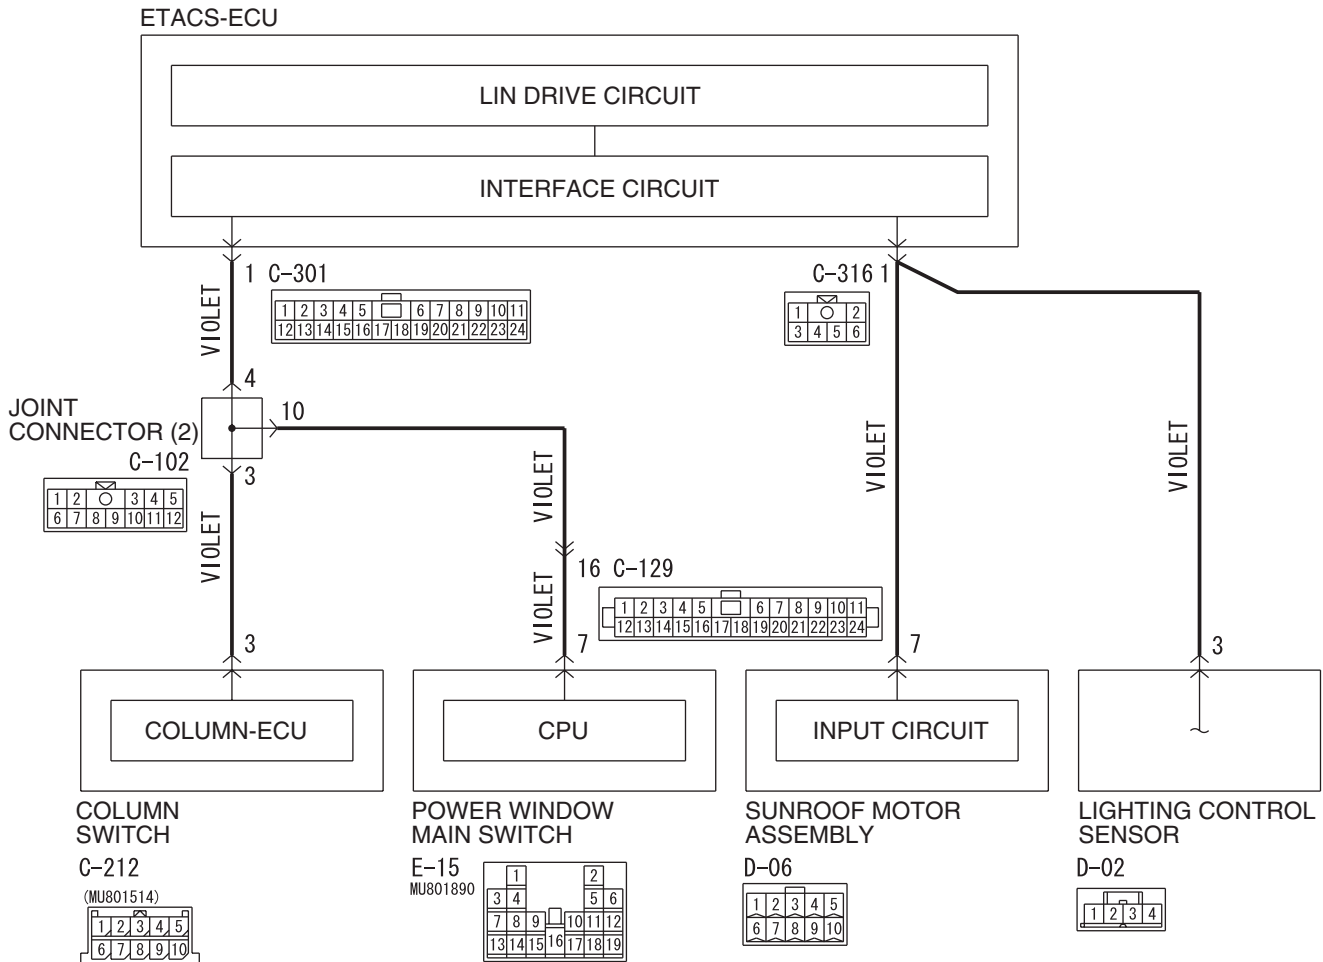
W8G54M186A

LIN Communication Circuit

The ETACS-ECU will set DTC U1515 when no communication has been carried out for more than a certain period after the slave task received last valid data.

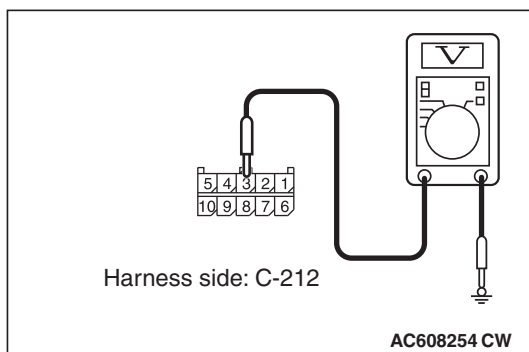
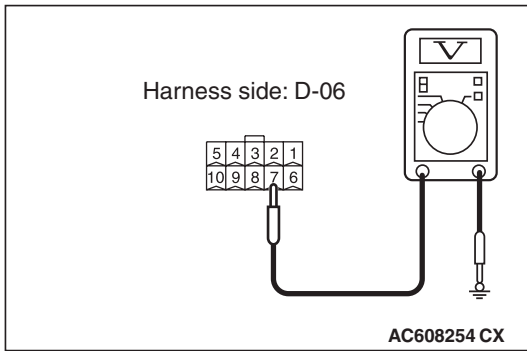
- (1) Disconnect all the ECU connectors which are connected to the LIN bus lines.
- (2) Turn the ignition switch from "LOCK" (OFF) to "ON" position
- (3) Measure the voltage between column switch connector C-212 (terminal 3) and ground.
 - The voltmeter needle does not swing.

- (4) Measure the voltage between sunroof motor assembly connector D-06 (terminal 7) and ground.
- The voltmeter needle does not swing.
- NOTE: If the LIN bus lines are short to power supply, the voltmeter indicates a constant value.*

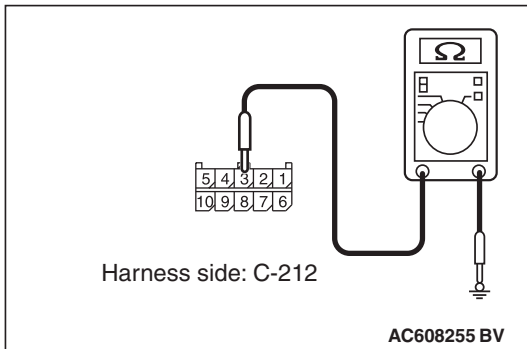
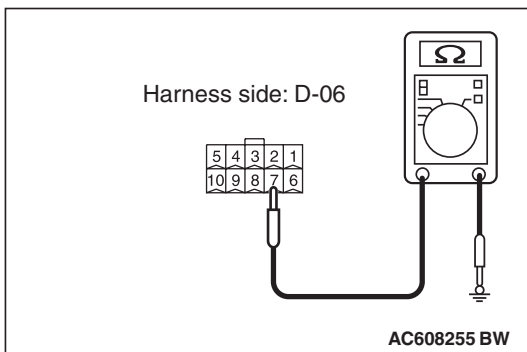
- Disconnect all the ECU connectors which are connected to the LIN bus lines.
- Measure the resistance value between column switch connector C-212 (terminal 3) and ground.
 - No continuity (1 kΩ or more)

- Measure the resistance value between sunroof motor assembly connector D-06 (terminal 7) and ground.
 - No continuity (1 kΩ or more)
