GROUP 54B**LOCAL
INTERCONNECT
NETWORK (LIN)****CONTENTS**

LIN refers to "Local Interconnect Network," which is a serial multiplex communication protocol* administered by LIN consortium. A communication circuit employing the LIN protocol connects each ECU, and switch and sensor data can be shared among ECUs, which enables more reduction in wiring.

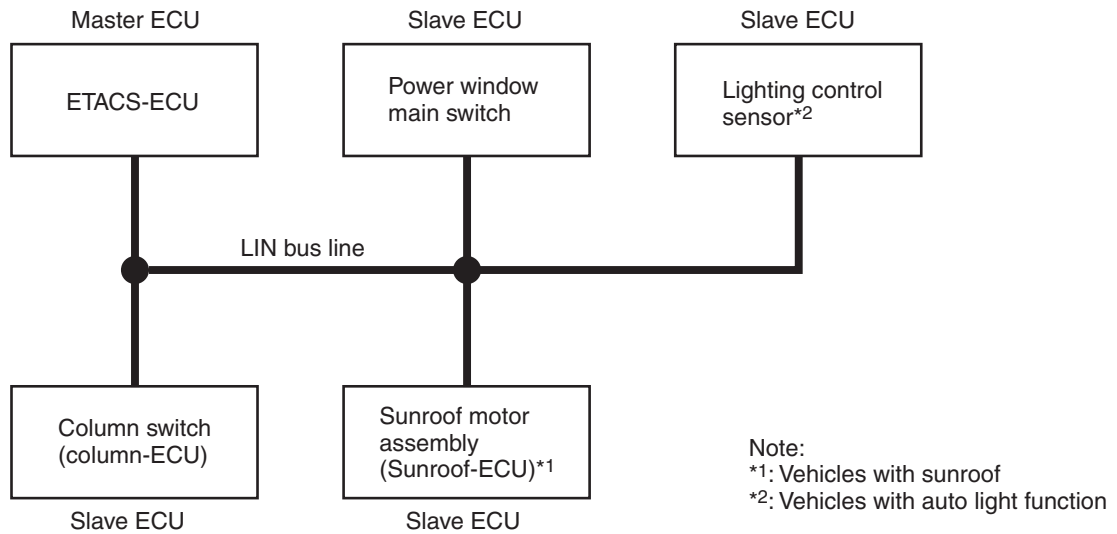
AC708922AB

Master and slave ECUs are connected to the LIN bus lines. The master ECU is the ETACS*¹-ECU, and the slave ECUs are the column switch (column-ECU), the power window main switch, the sunroof-ECU*² and the lighting control sensor*³. The master ECU requests these slave ECUs to communicate each other via communication lines.

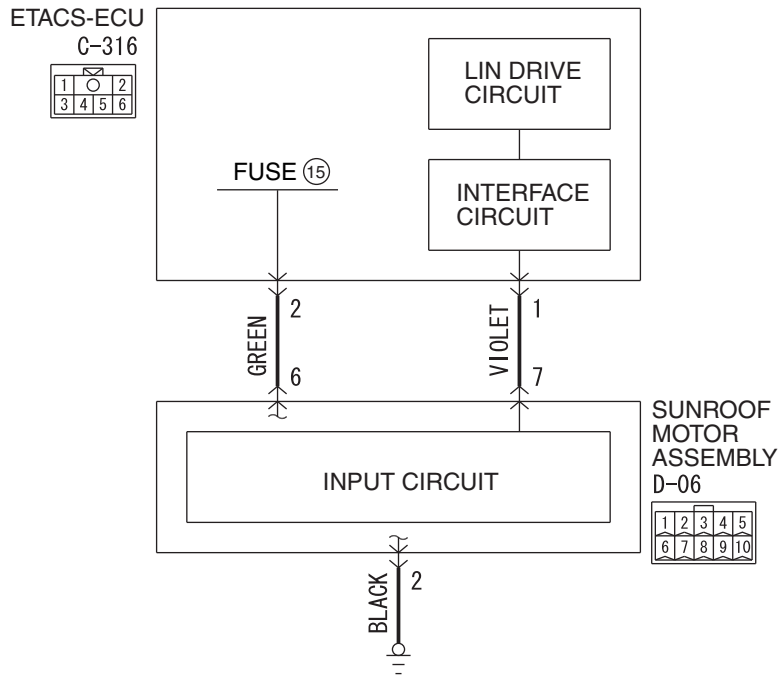
Sunroof Motor Assembly LIN Communication Circuit

The ETACS-ECU receives signal from the sunroof motor assembly (sunroof-ECU). If signal cannot be received at all, DTC U0169 will be set.

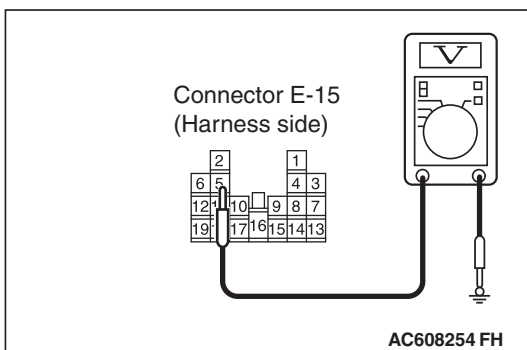
STEP 5. Check the wiring harness between ETACS-ECU connector C-315 (terminal 10) and power window main switch connector E-15 (terminal 5).

- Check the power supply line (battery supply) for open circuit and short circuit.

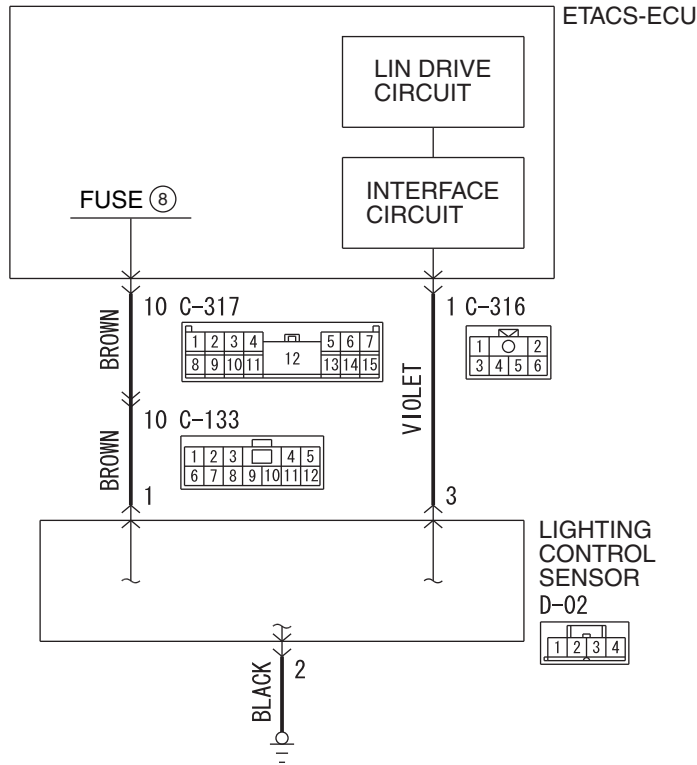
Lighting Control Sensor LIN Communication Circuit

The ETACS-ECU receives signal from the lighting control sensor. If signal cannot be received at all, DTC U0231 will be set.

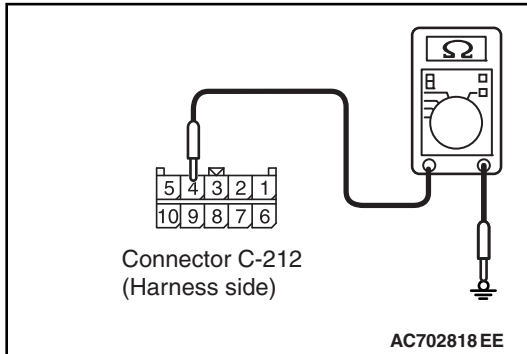
STEP 2. Check the ground circuit to the column switch. Measure the resistance at column switch connector C-212.

- (1) Disconnect column switch connector C-212 and measure the resistance available at the wiring harness side of the connector.
- (2) Measure the resistance value between column switch connector C-212 terminal 4 and ground.
 - The resistance should be 2 ohms or less.

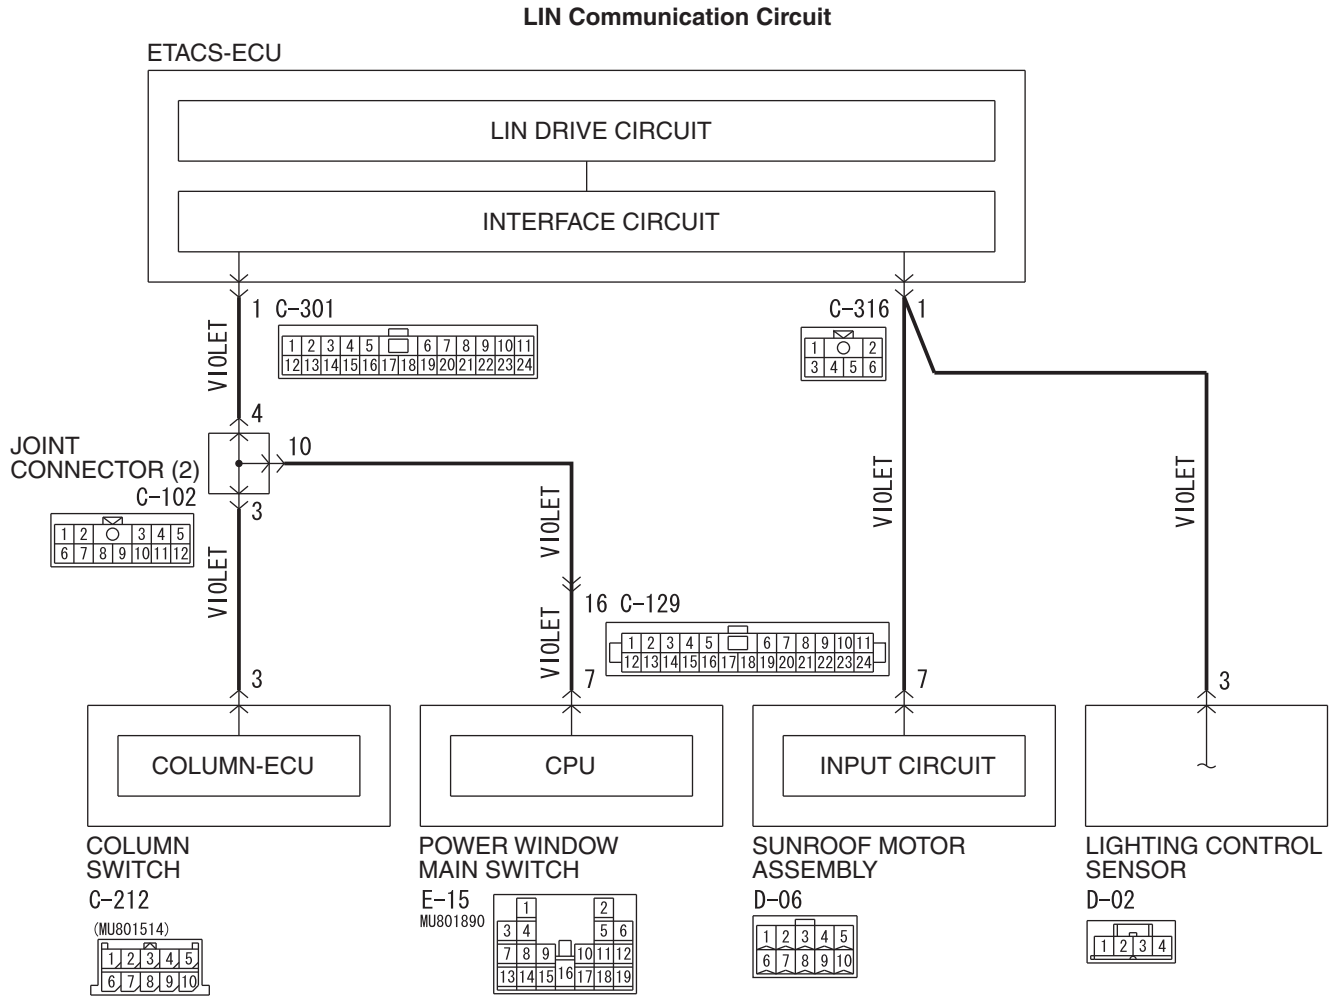
DTC U1515: No-Bus activity error (LIN)

The ETACS-ECU will set DTC U1515 when no communication has been carried out for more than a certain period after the slave task received last valid data.
