## **GROUP 52B**

# SUPPLEMENTAL RESTRAINT SYSTEM (SRS)

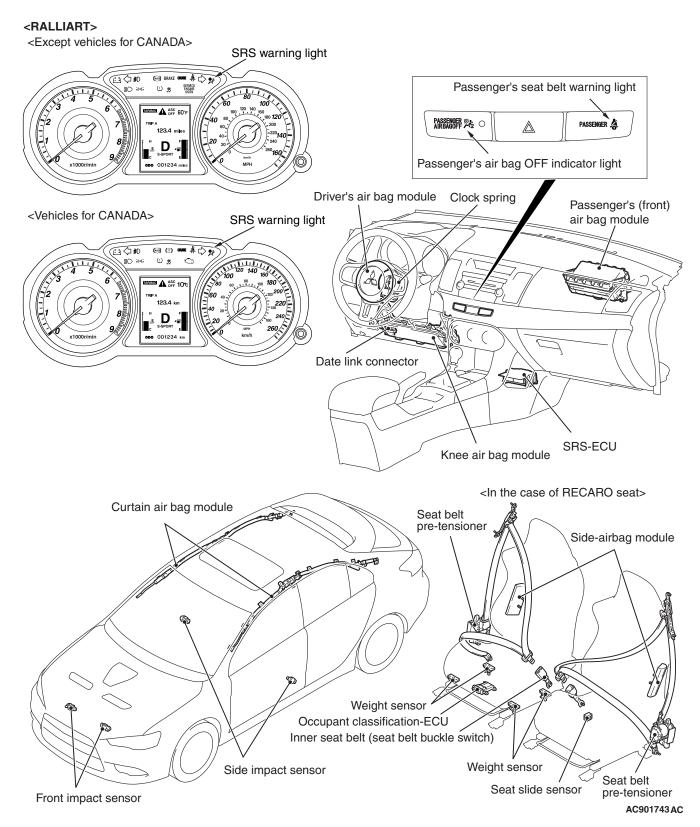
## **CONSTRUCTION DIAGRAM**

NOTE: This construction diagram shows the general view of the SRS components. For details, refer to "Schematic(P.52B-10), "Configuration Diagrams (P.52B-13), " and "Circuit Diagram(P.52B-15)".

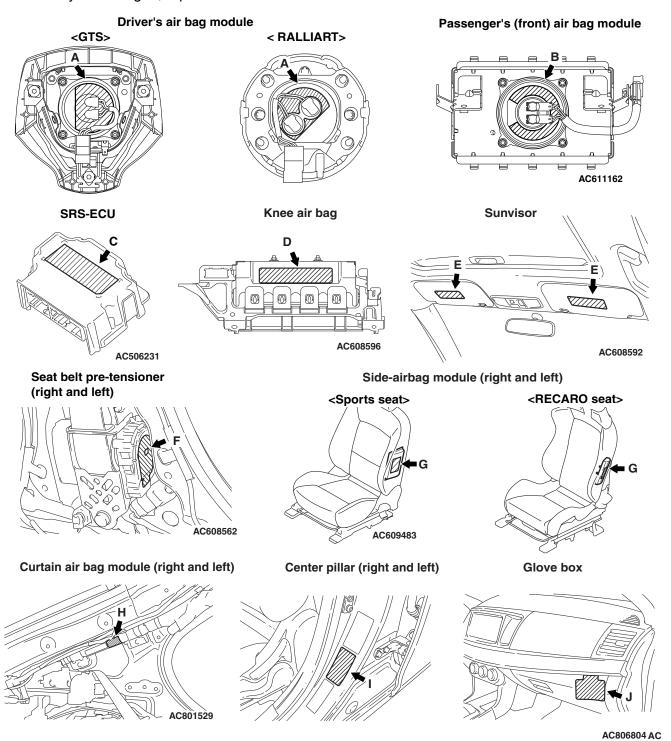
A number of caution labels related to the SRS are found in the vehicle, as shown in the following illustrations. Follow label instructions when servicing SRS. The label I is not to be removed except by owner. If the other labels are dirty or damaged, replace them.

Label contents	
A, B	DANGER FLAMMABLE EXPLOSIVE DO NOT: DISASSEMBLE; HEAT; INCINERATE; APPLY ELECTRICITY; OR STORE AT HIGH TEMPERATURE (93°C or HIGHER). REFER TO WORKSHOP MANUAL FOR DETAILS.
С	CAUTION: DO NOT DISASSEMBLE OR DROP. IF DEFECTIVE, REFER TO SERVICE MANUAL.
D	DANGER FLAMMABLE EXPLOSIVE SRS AIR BAG MODULE  • Do not disassemble or shock.  • Do not heat or incinerate.  • Do not contact with electricity or tester probes.  • Do not test or diagnose.  • Do not store in more than 200° F (93° C).  • Store the air bag cover is top.  • For information on handing, replacement, and disposal methods, refer to the service manual.
E <except VEHICLES FOR CANADA&gt;</except 	WARNING EVEN WITH ADVANCED AIR BAGS  Children can be killed or seriously injured by the air bag The back seat is the safest place for children  Never put a rear-facing child seat in the front Always use seat belts and child restraints See owner's manual for more information about air bags

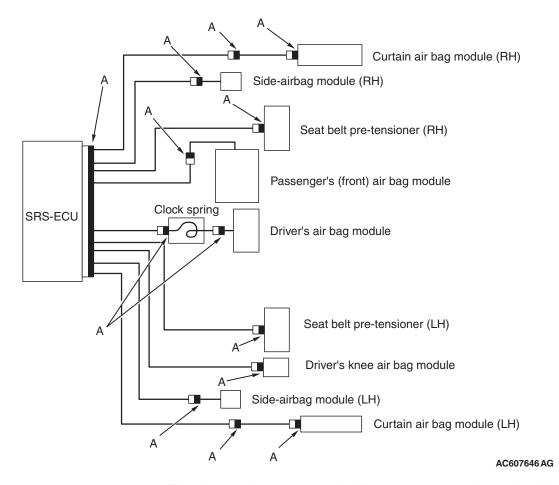
## SRS AIR BAG SPECIAL CONNECTOR

To enhance the system reliability, a connector short circuiting mechanism is integrated in the SRS-ECU connector, air bag module connectors, clock spring connector, pre-tensioner connectors, and intermediate connector between curtain air bag module and SRS-ECU (black connector "A" shown in the figure).

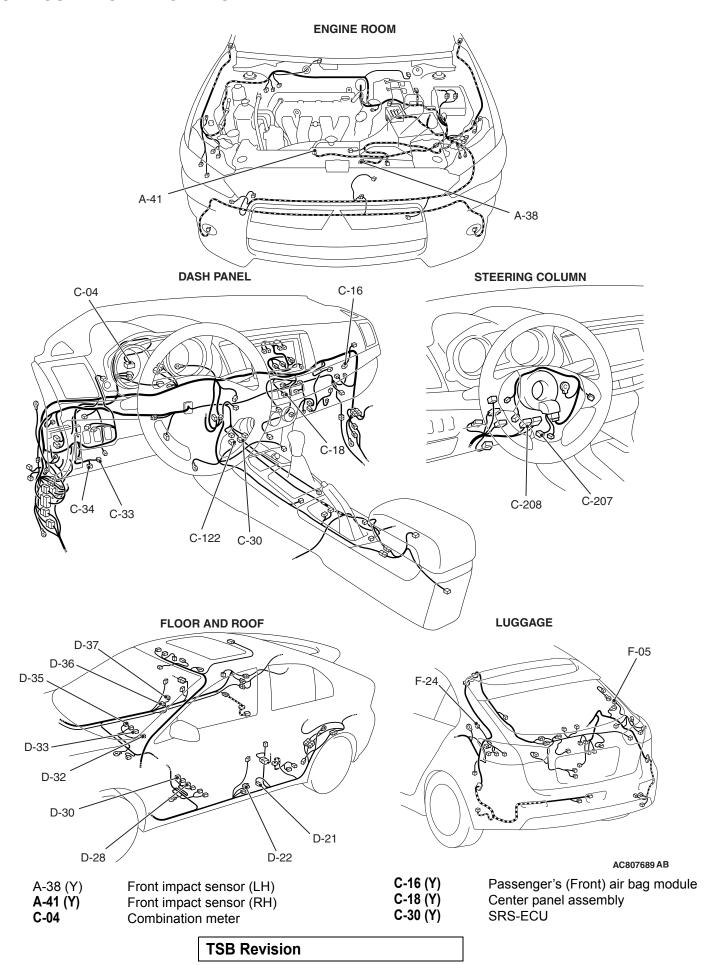
### **CONFIGURATION DIAGRAMS**

C-33 (B)	Knee air bag module
C-34 (B)	Date link connector
C-122 (Y)	SRS-ECU
C-207 (Y)	Driver's air bag module
C-208 (Y)	Clock spring
D-21 (B)	Seat belt pre-tensioner (LH)
D-22 (Y)	Side impact sensor (LH)
D-28 (GR)	Seat slide sensor
D-30 (Y)	Side-airbag module (LH)
D-32 (Y)	Side-airbag module (RH)
D-33 (B)	Seat belt buckle switch
	(Passenger's side)
D-35	Front seat assembly (RH) (weight
	sensor, occupant
	classification-ECU)
D-36 (B)	Seat belt pre-tensioner (RH)
D-37 (Y)	Side impact sensor (RH)
F-05 (B)	Curtain air bag module (RH)
F-24 (B)	Curtain air bag module (LH)

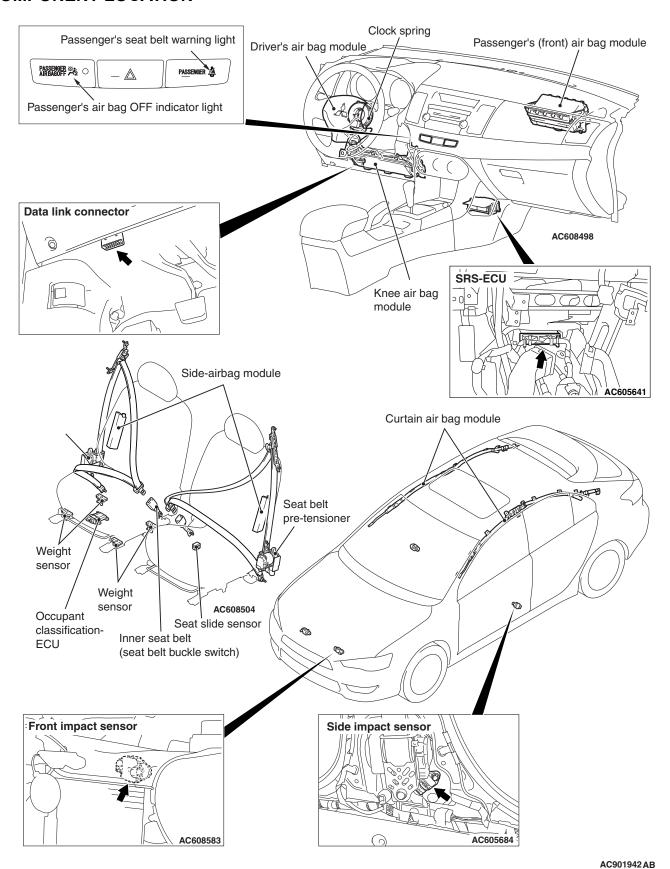
## **COMPONENT LOCATION**

NOTE: The illustration above shows the front impact sensor (LH) and the side impact sensor (LH). The position of the front impact sensor (RH) and the side impact sensor (RH) is symmetrical to this.

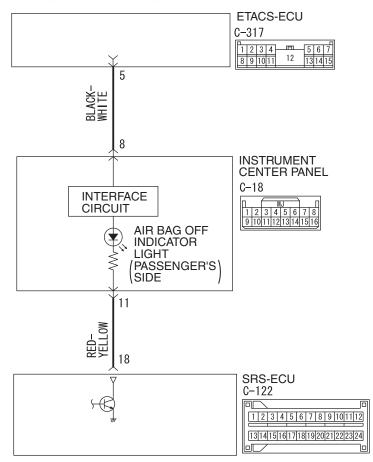
AC710663AB

#### Air Bag OFF Indicator Light Drive Circuit

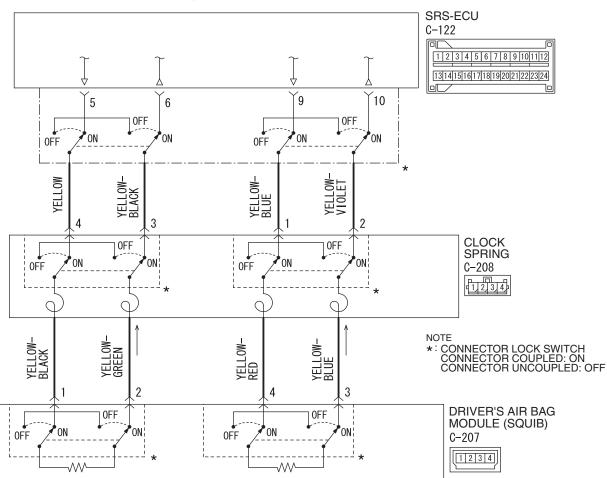
W8G52M004A

#### Driver's Air Bag Module (Squib) Circuit

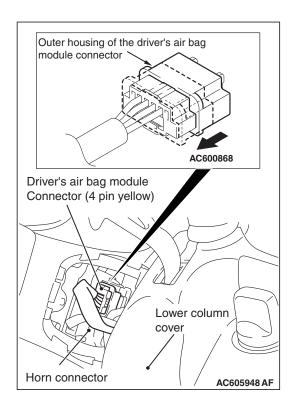
- (1) Disconnect the negative battery terminal.
- (2) Slide the outer housing of the driver's air bag module connector C-207 in the arrow direction shown, and disconnect the connector.

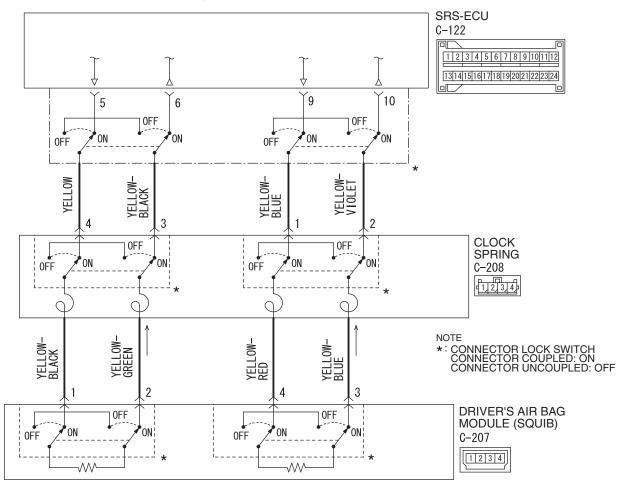
W8G52M004A

#### Driver's Air Bag Module (Squib) Circuit

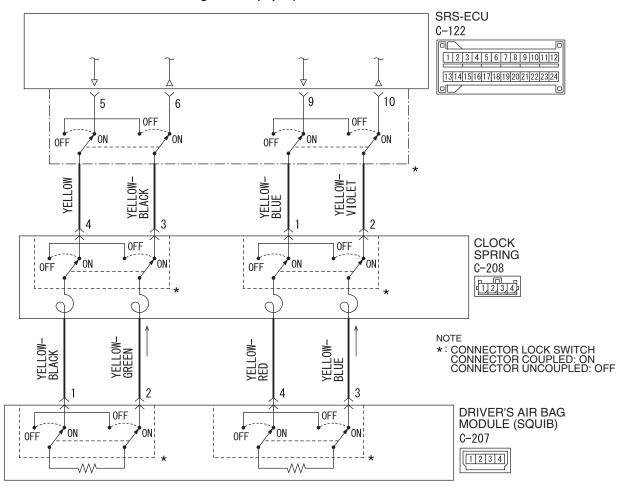
W8G52M004A

#### Driver's Air Bag Module (Squib) Circuit

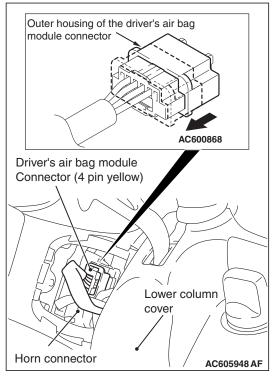
- (1) Disconnect the negative battery terminal.
- (2) While pressing the part A in the illustration of the C-122 SRS-ECU harness side connector, turn the lock lever toward the arrow direction to release the lock lever. Then, disconnect the connector and reconnect it.

- (3) Disconnect the C-208 clock spring connector and C-207 driver's air bag module connector, and then reconnect them. Disconnect C-207 driver's air bag module connector while sliding its outer housing toward the arrow direction in the illustration.
- (4) Connect the negative battery terminal.
- (5) Erase the diagnostic trouble code memory, and check the diagnostic trouble code.
- Q: Is DTC B1B03 <1st squib> or B1B07 <2nd squib> set? YES: Go to Step 4.

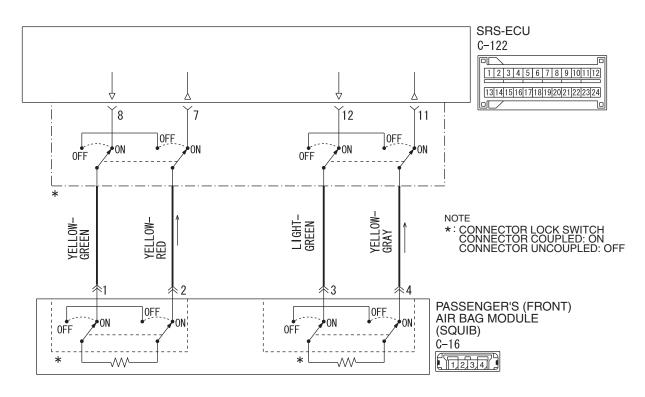
#### Passenger's (Front) Air Bag Module (Squib) Circuit

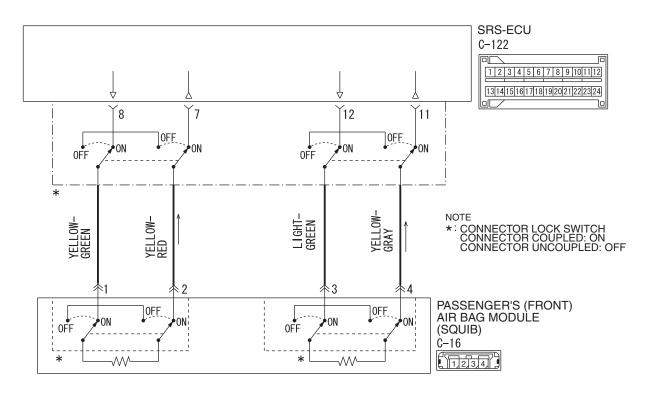
#### Passenger's (Front) Air Bag Module (Squib) Circuit

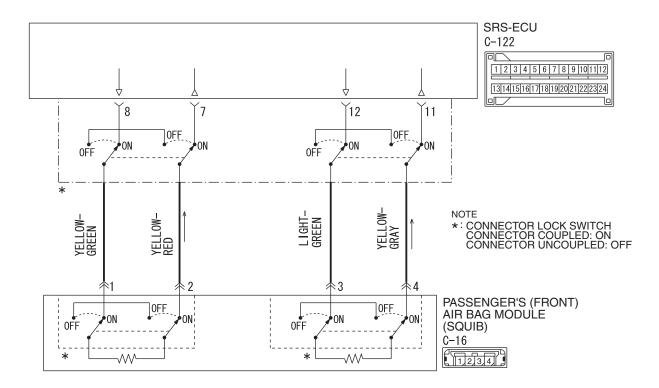
#### Passenger's (Front) Air Bag Module (Squib) Circuit

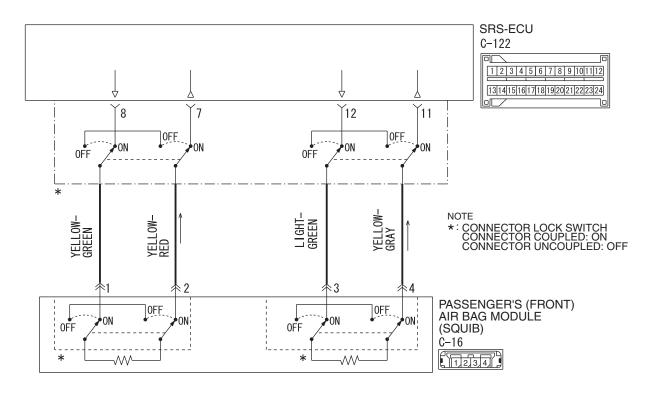
AC802638 AB

#### Passenger's (Front) Air Bag Module (Squib) Circuit

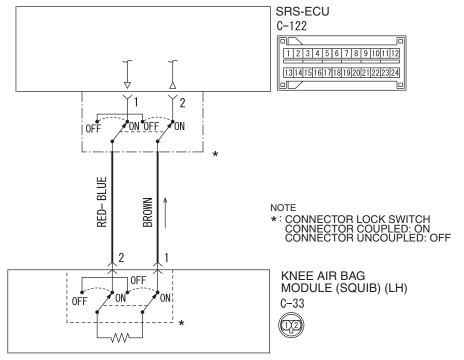
W8G52M018A

#### Knee Air Bag Module (Squib) Circuit

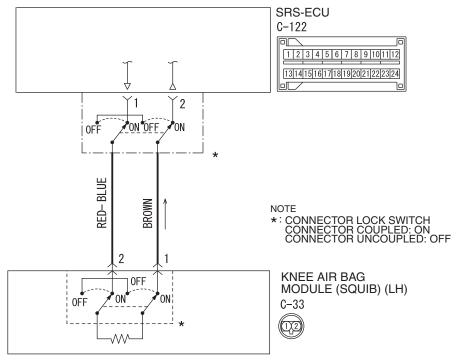
W8G52M018A

#### Knee Air Bag Module (Squib) Circuit

- Improper connector contact
- Open circuit in the knee air bag module (squib) circuit
- Malfunction of the SRS-ECU

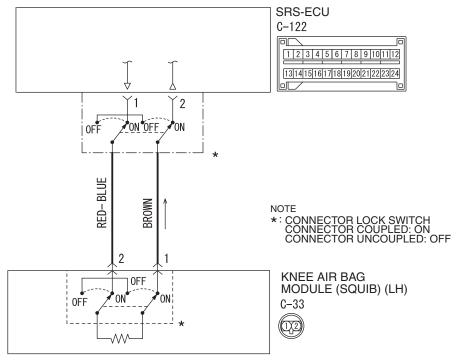
W8G52M018A

#### Knee Air Bag Module (Squib) Circuit

- Improper engaged connector or defective short spring\*
- Short circuit between the knee air bag module (squib) circuit terminals
- Damaged connector(s)

NOTE: \*: The squib circuit connectors integrate a "short" spring (which prevents the knee air bag module from deploying unintentionally due to static electricity by shorting the positive wire to the ground wire in the squib circuit when the connectors are disconnected) (Refer to P.52B-3). Therefore, if connector C-122 or C-33 is damaged or improperly engaged, the short spring may not be released when the connector is connected.

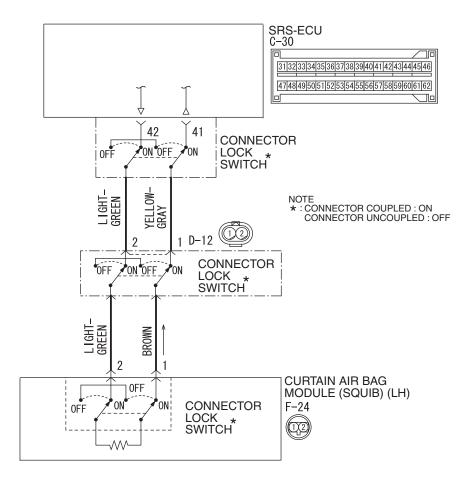
AC710900 AB

#### Curtain Air Bag Module (Squib) (LH) Circuit

- · Damaged wiring harnesses or connectors
- Short to the ground in the curtain air bag module (LH) (squib) harness
- Malfunction of the SRS-ECU

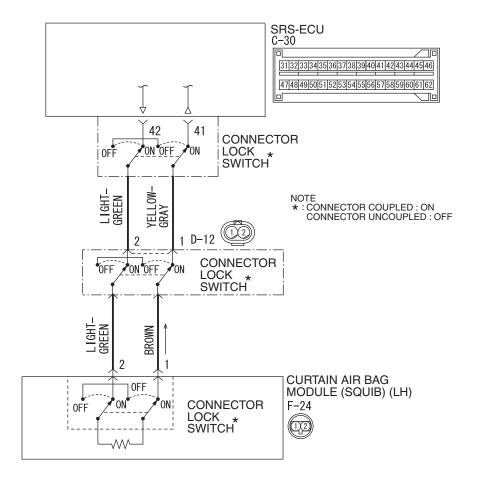
AC710900 AB

#### Curtain Air Bag Module (Squib) (LH) Circuit

- · Damaged wiring harnesses or connectors
- Short to the power supply in the curtain air bag module (LH) (squib) harness
- Malfunction of the SRS-ECU

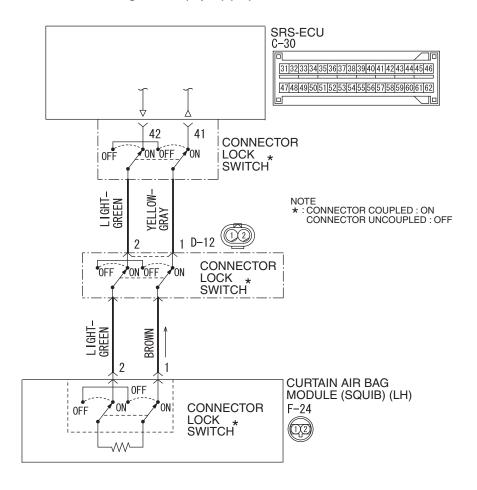
AC710900 AB

#### Curtain Air Bag Module (Squib) (LH) Circuit

- Open circuit in the curtain air bag module (LH) (squib) circuit
- Improper connector contact
- · Malfunction of the SRS-ECU

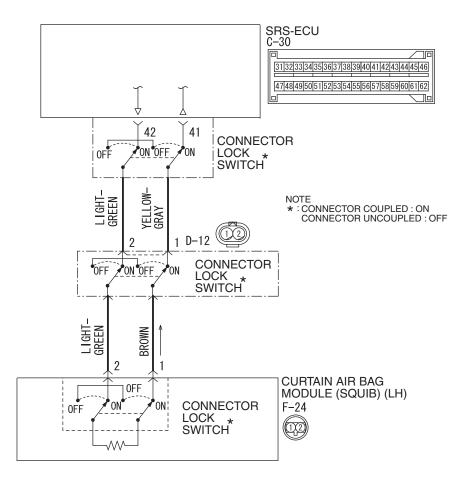
AC710900 AB

#### Curtain Air Bag Module (Squib) (LH) Circuit

- Improper engaged connector or defective short spring\*
- Short circuit between the curtain air bag module (LH) (squib) circuit terminals
- Damaged connector(s)
- · Malfunction of the SRS-ECU

NOTE: \*: The squib circuit connectors integrate a "short" spring (which prevents the air bag from deploying unintentionally due to static electricity by shorting the positive wire to the ground wire in the squib circuit when the connectors are disconnected) (Refer to P.52B-3). Therefore, if connector C-30, D-12 or F-24 is damaged or improperly engaged, the short spring may not be released when the connector is connected.

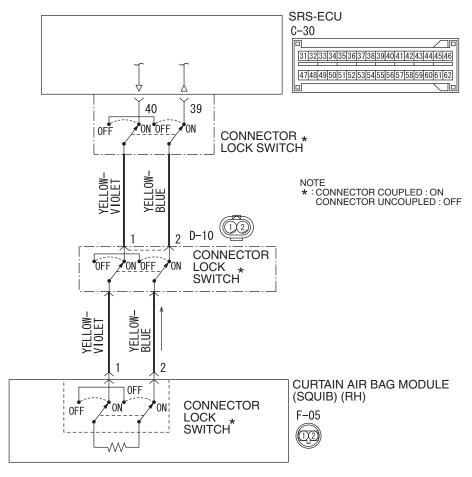
AC710901AB

#### Curtain Air Bag Module (Squib) (RH) Circuit

- · Damaged wiring harnesses or connectors
- Short to the ground in the curtain air bag module (RH) (squib) harness
- · Malfunction of the SRS-ECU

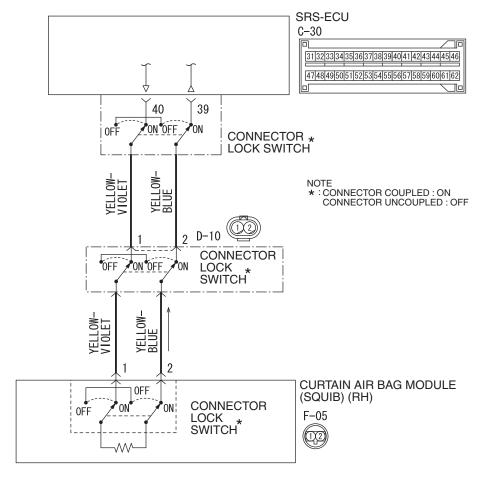
AC710901AB

# Curtain Air Bag Module (Squib) (RH) Circuit

- · Damaged wiring harnesses or connectors
- Short to the power supply in the curtain air bag module (RH) (squib) harness
- Malfunction of the SRS-ECU

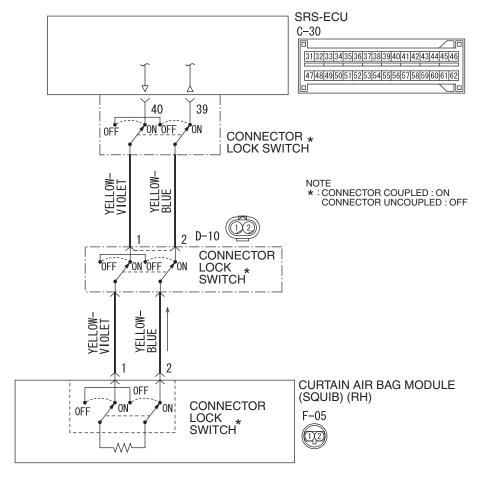
#### AC710901AB

# Curtain Air Bag Module (Squib) (RH) Circuit

- Open circuit in the curtain air bag module (RH) (squib) circuit
- Improper connector contact
- · Malfunction of the SRS-ECU

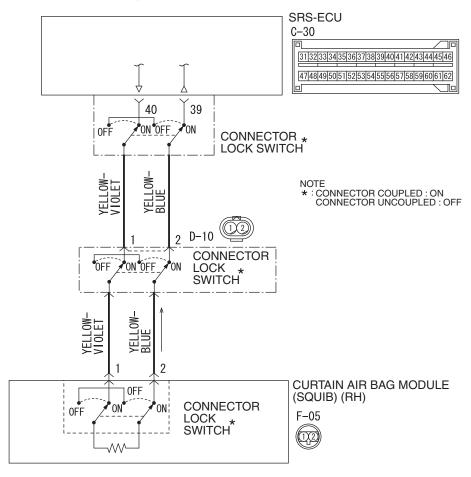
AC710901AB

#### Curtain Air Bag Module (Squib) (RH) Circuit

- Improper engaged connector or defective short spring\*
- Short circuit between the curtain air bag module (RH) (squib) circuit terminals
- Damaged connector(s)
- · Malfunction of the SRS-ECU

NOTE: \*: The squib circuit connectors integrate a "short" spring (which prevents the air bag from deploying unintentionally due to static electricity by shorting the positive wire to the ground wire in the squib circuit when the connectors are disconnected) (Refer to P.52B-3). Therefore, if connector C-30, D-10 or F-05 is damaged or improperly engaged, the short spring may not be released when the connector is connected.

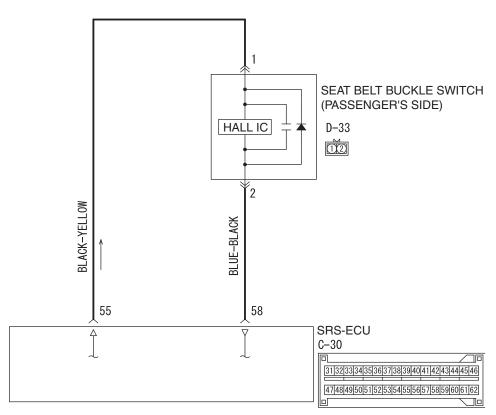
AC802716 AC

DTC B1B56: Seat Belt Buckle Switch (RH) Circuit Open

#### **Seat Belt Switch Circuit**

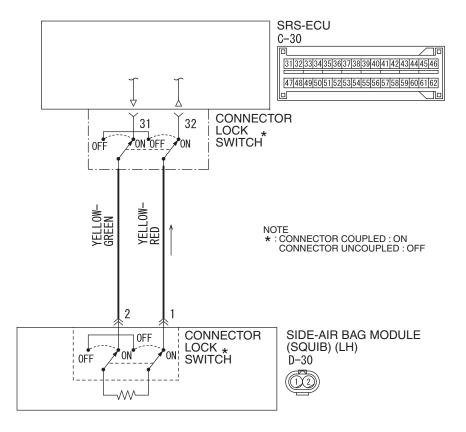
W8G52M009A

## DTC B1C27: Side-airbag Module (LH) (Squib) System (Shorted to Squib Circuit Ground)

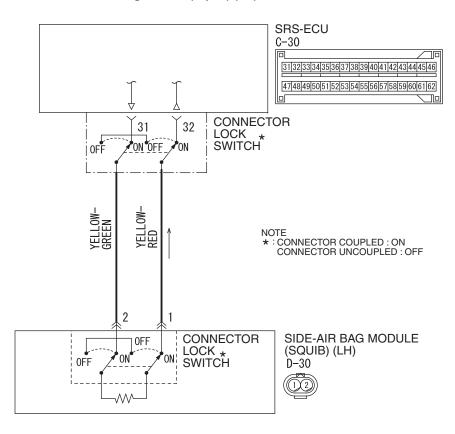
W8G52M009A

## DTC B1C28: Side-airbag Module (LH) (Squib) System (Shorted to Squib Circuit Power Supply)

#### Side-airbag Module (Squib) (LH) Circuit

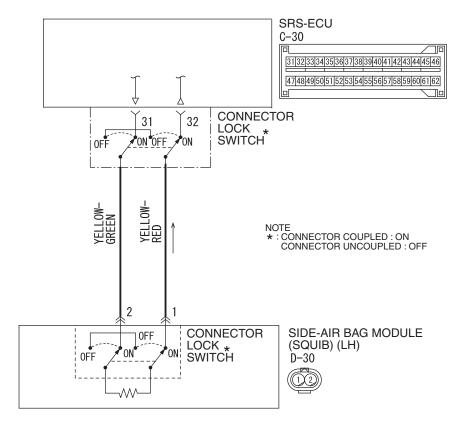
W8G52M009A

## DTC B1C29: Side-airbag Module (LH) (Squib) System (Squib Circuit Open)

#### Side-airbag Module (Squib) (LH) Circuit

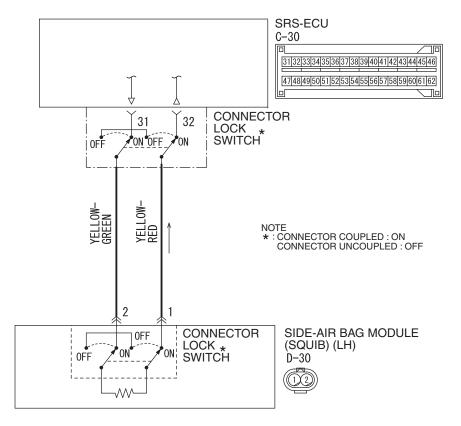
W8G52M009A

## DTC B1C2A: Side-airbag Module (LH) (Squib) System (Short Circuit between Squib Circuit Terminals)

#### Side-airbag Module (Squib) (LH) Circuit

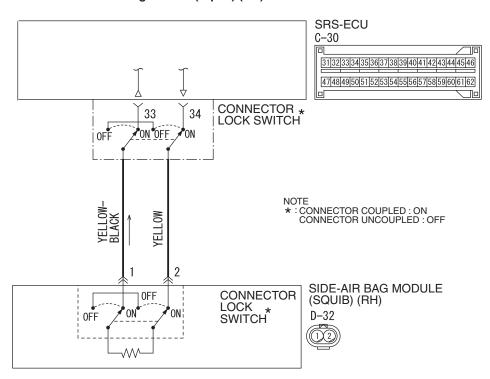
#### DTC B1C2E: Side-airbag Module (RH) (Squib) System (Short Circuit between Squib Circuit Terminals)

#### Side-airbag Module (Squib) (RH) Circuit

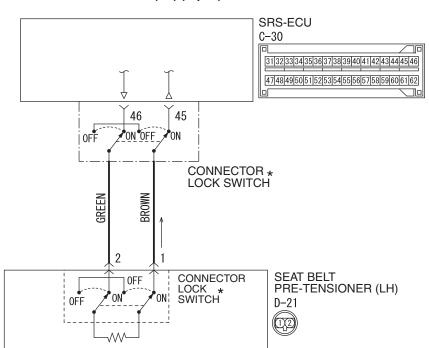
#### DTC B1C38: Driver's Seat Belt Pre-tensioner (Squib) System (Shorted to Squib Circuit Ground)

#### Seat Belt Pre-Tensioner (LH) (Squib) Circuit

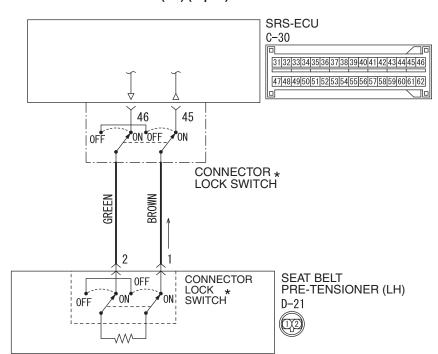
W8G52M011A

#### DTC B1C3A: Driver's Seat Belt Pre-tensioner (Squib) System (Squib Circuit Open)

#### Seat Belt Pre-Tensioner (LH) (Squib) Circuit

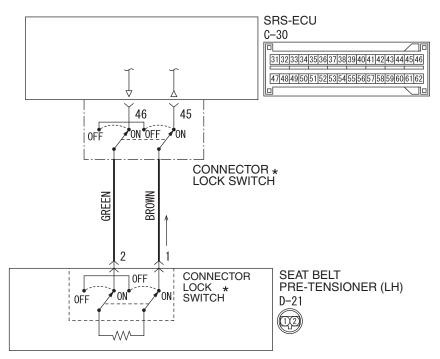
W8G52M011A

## DTC B1C3B: Driver's Seat Belt Pre-tensioner (Squib) System (Short Circuit Between Squib Circuit Terminals)

#### Seat Belt Pre-Tensioner (LH) (Squib) Circuit

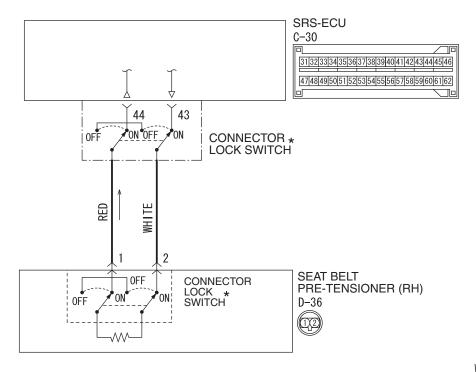
W8G52M012A

## DTC B1C47: Front Passenger's Seat Belt pre-tensioner (squib) system (shorted to squib circuit Ground)

#### Seat Belt Pre-Tensioner (RH) (Squib) Circuit

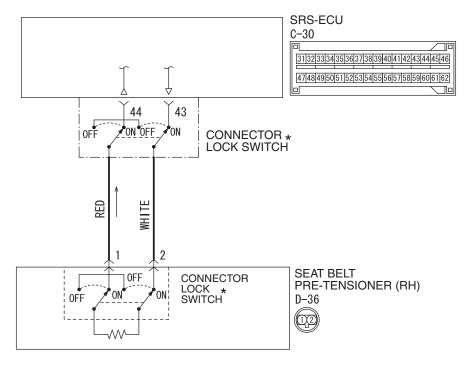
W8G52M012A

DTC B1C48: Front Passenger's Seat Belt Pre-tensioner (Squib) System (Shorted to Squib Circuit Power Supply)

#### Seat Belt Pre-Tensioner (RH) (Squib) Circuit

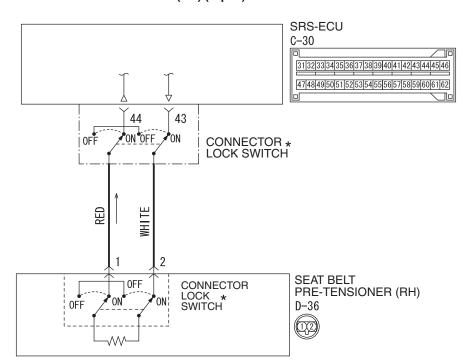
#### DTC B1C49: Front Passenger's Seat Belt Pre-tensioner (Squib) System (Squib Circuit Open)

#### Seat Belt Pre-Tensioner (RH) (Squib) Circuit

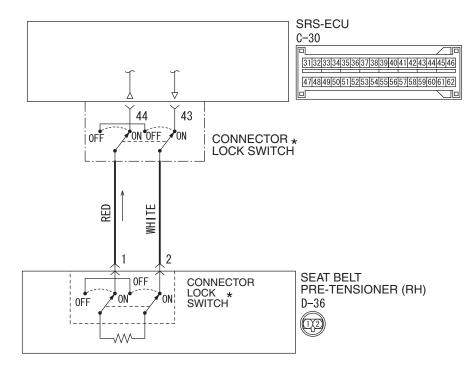
W8G52M012A

DTC B1C4A: Front Passenger's Seat Belt Pre-tensioner (Squib) System (Short Circuit between Squib Circuit Terminals)

#### Seat Belt Pre-Tensioner (RH) (Squib) Circuit

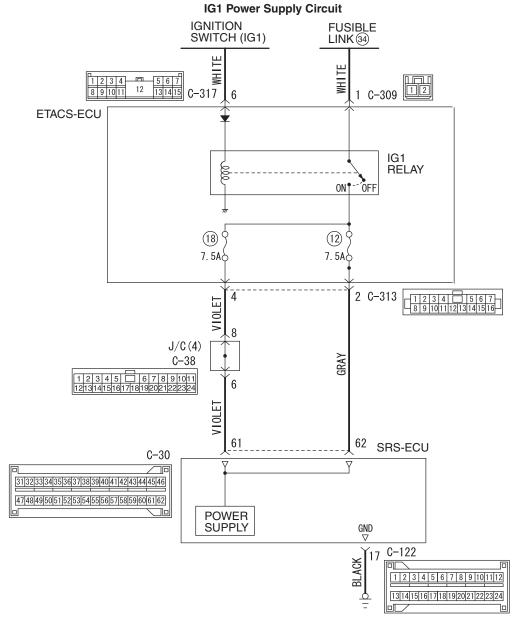
AC807383 AB

#### **DTC B210D: Battery Abnormal Low Voltage**

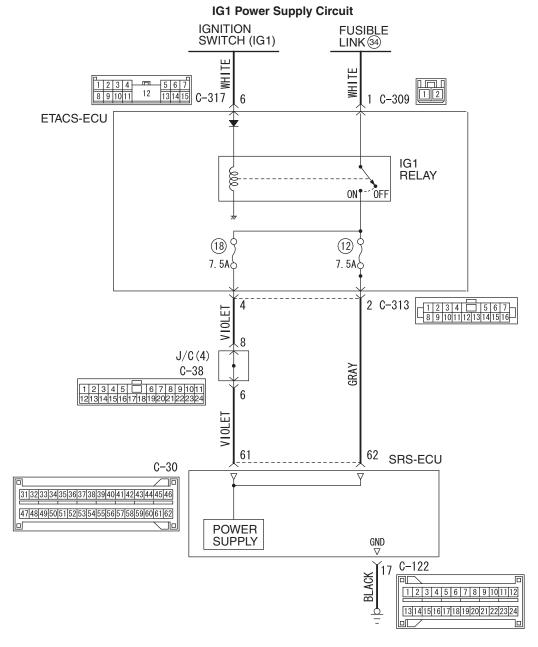
DTC B212C: Open Circuit to IG1 Power Supply (Fuse No.12 Circuit) DTC B212D: Open Circuit to IG1 Power Supply (Fuse No.18 Circuit)

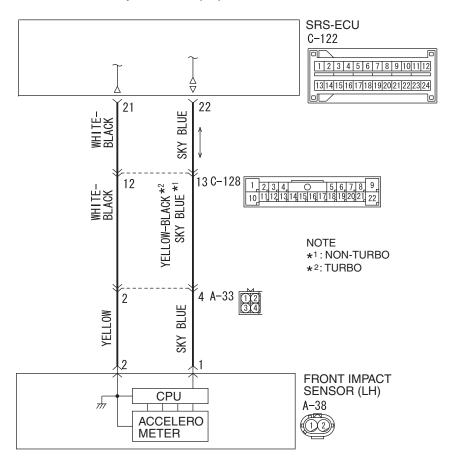
AC807388 AB

# DTC U0170: Front Impact Sensor (LH) Communication Error

#### Front Impact Sensor (LH) Circuit

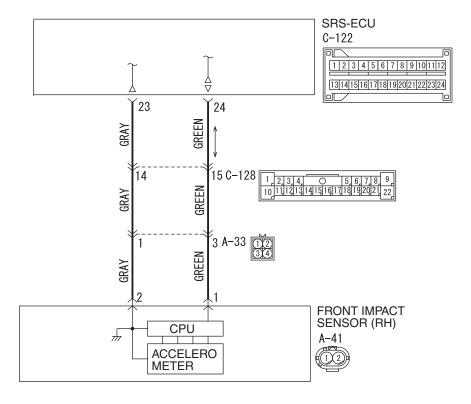
W8G52M014A

# DTC U0171: Front Impact Sensor (RH) Communication Error

#### Front Impact Sensor (RH) Circuit

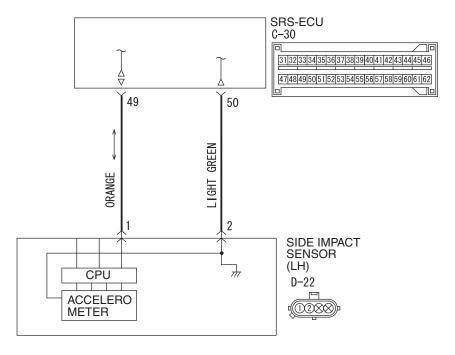
AC807379 AB

# DTC U0172: Side Impact Sensor (LH) Communication Error

### Side Impact Sensor (LH) Circuit

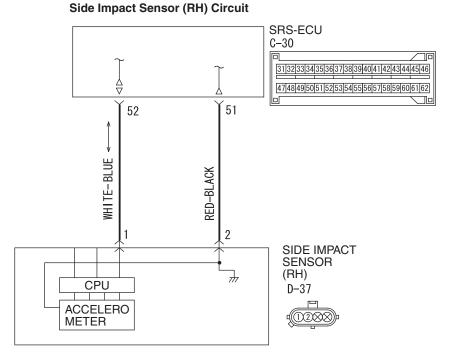
# AC807380 AB

# DTC U0175: Side Impact Sensor (RH) Communication Error

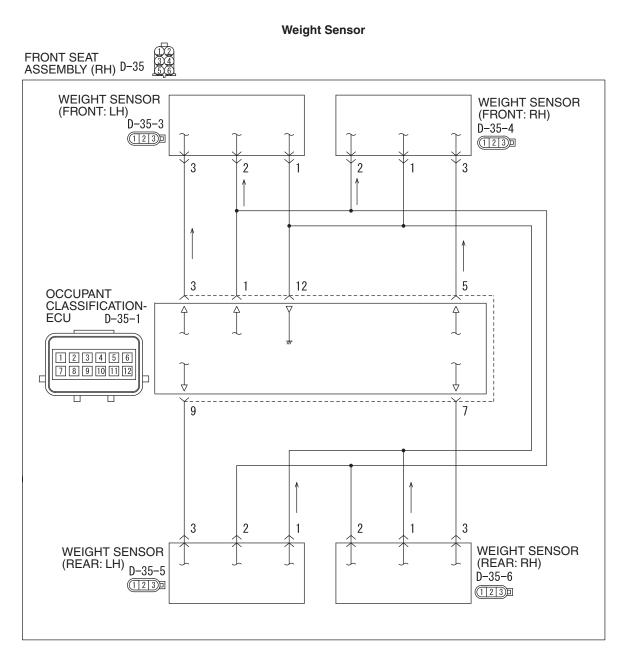
AC803894 AC

DTC B1B78: Passenger Seat Weight Sensor (front: LH) Performance DTC B1B7D: Passenger Seat Weight Sensor (front: RH) Performance DTC B1B82: Passenger Seat Weight Sensor (rear: LH) Performance DTC B1B87: Passenger Seat Weight Sensor (rear: RH) Performance

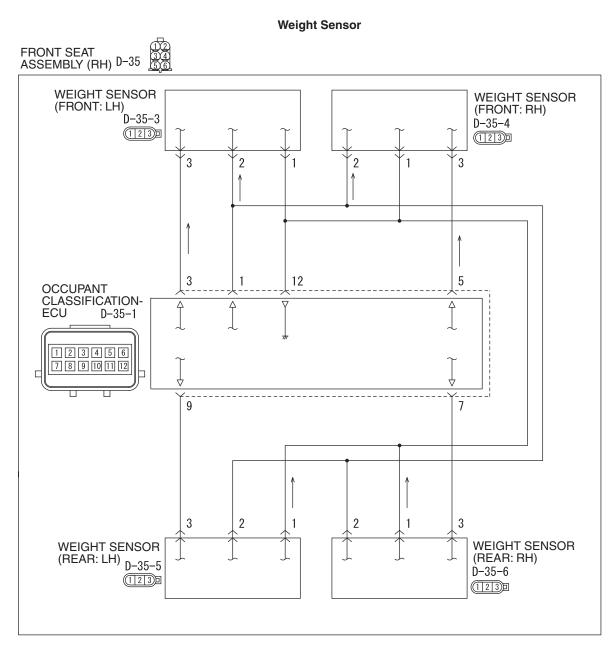
AC803894 AC

DTC B1B79: Passenger Seat Weight Sensor (ground side) Short-circuited (front: LH) DTC B1B7E: Passenger Seat Weight Sensor (ground side) Short-circuited (front: RH) DTC B1B83: Passenger Seat Weight Sensor (ground side) Short-circuited (rear: LH) DTC B1B88: Passenger Seat Weight Sensor (ground side) Short-circuited (rear: RH)

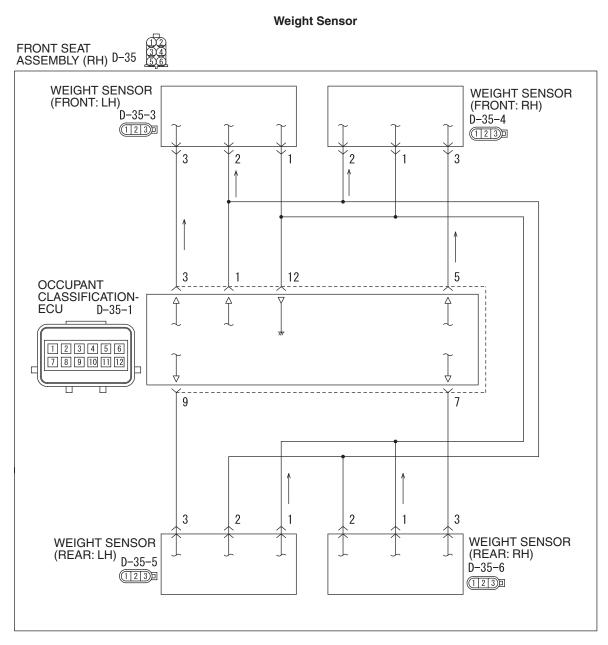
AC803894 AC

DTC B1B7A: Passenger Seat Weight Sensor (power supply side) Short-circuited or Open (front: LH) DTC B1B7F: Passenger Seat Weight Sensor (power supply side) Short-circuited or Open (front: RH) DTC B1B84: Passenger Seat Weight Sensor (power supply side) Short-circuited or Open (rear: LH) DTC B1B89: Passenger Seat Weight Sensor (power supply side) Short-circuited or Open (rear: RH)

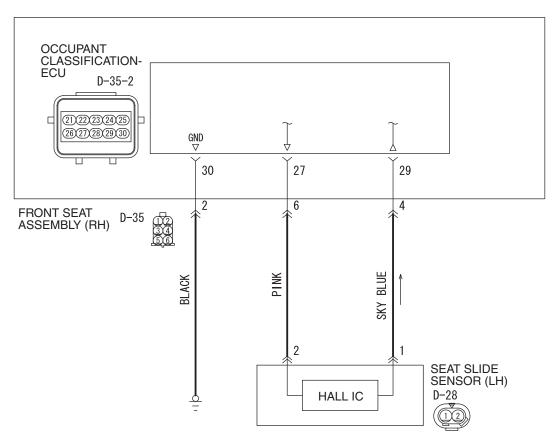
AC710858 AC

#### **Seat Slide Sensor Circuit**

- The seat slide sensor may be defective.
- The wiring harness or connectors may have loose, corroded, or damaged terminals, or terminals pushed back in the connector
- · Malfunction of the occupant classification-ECU

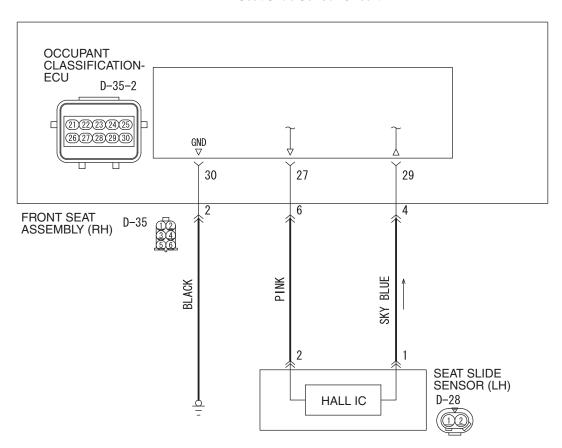
AC710858 AC

#### **Seat Slide Sensor Circuit**

- This DTC is set if there is abnormal resistance between the input terminals of the seat slide sensor. The most likely causes for this code to be set are the followings:
  - Open circuit in the seat slide sensor or harness

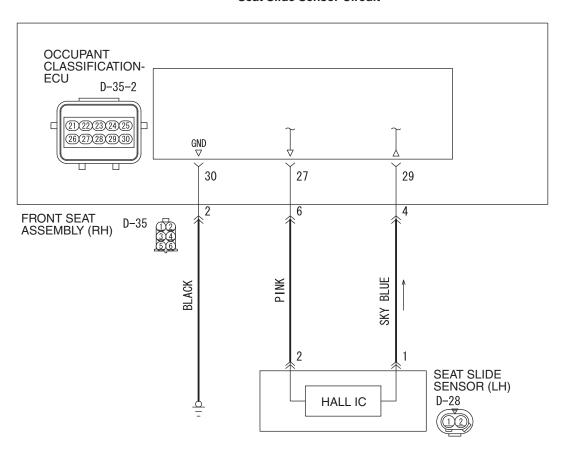
AC710858 AC

#### **Seat Slide Sensor Circuit**

- Damaged wiring harnesses or connectors
- Short to the power supply in the seat slide sensor harness
- · Malfunction of the seat slide sensor
- · Malfunction of the occupant classification-ECU

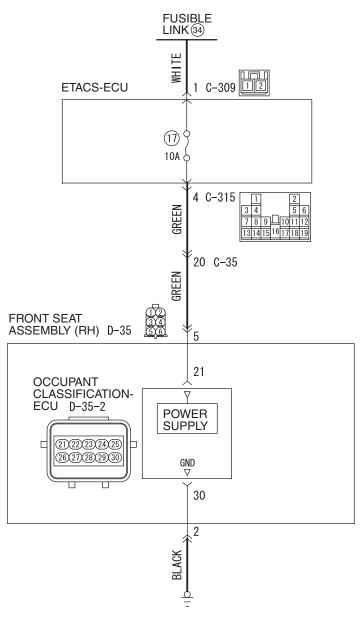
AC710859 AC

#### **Occupant Classification-ECU Power Supply Circuit**

- The power supply fuse may be defective.
- The occupant classification-ECU may be defective.
- The battery may be defective.
- The generator may be defective.
- The wiring harness or connectors may have loose, corroded, or damaged terminals, or terminals pushed back in the connector

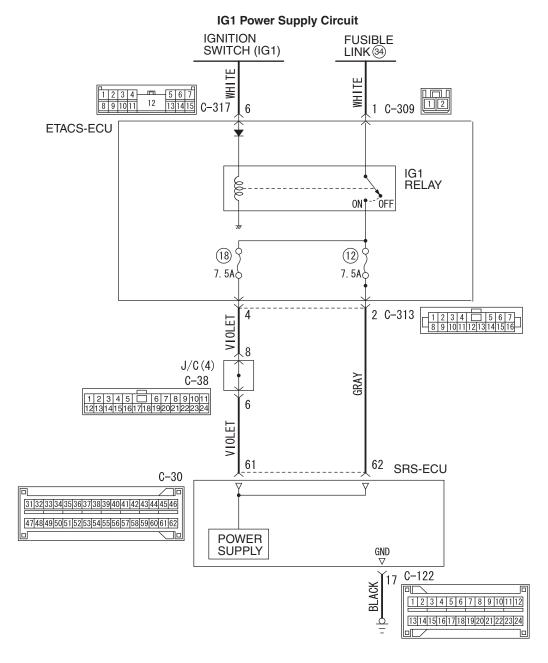
AC807383 AB

# Inspection procedure 2: Power supply circuit system

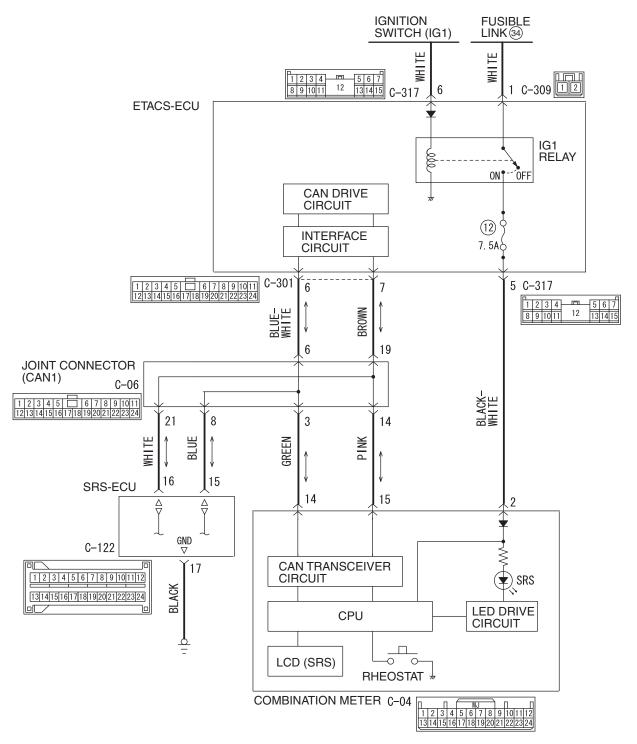
AC802774 AC

#### **SRS Warning Light Circuit**

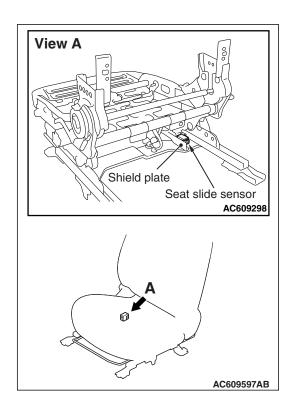
NOTE: The illustration shows the side impact sensor (LH). The position of the side impact sensor (RH) is symmetrical to this.

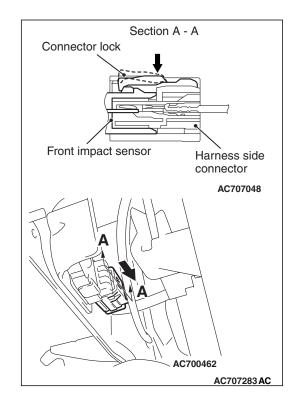
Press the connector lock of the harness side connector of the front impact sensor to release the lock. Then, remove the harness side connector by pulling it in the direction of the arrow.

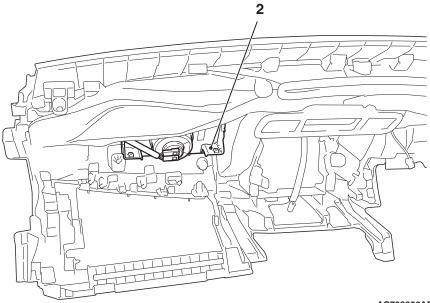
AC709086AB

## PASSENGER'S (FRONT) AIR BAG MODULE

## Passenger's (front) air bag module removal steps

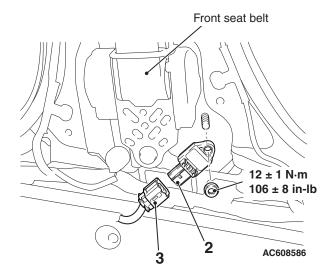
AC609672 AC

# Side impact sensor removal steps

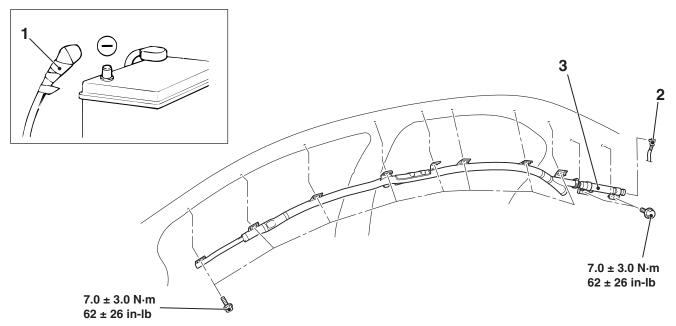
AC608584 AE

#### Removal steps <<A>>

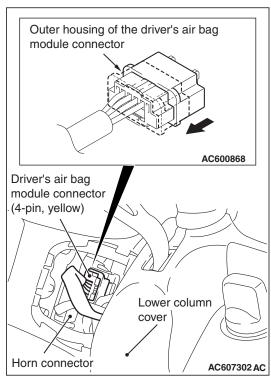
Slide the outer housing of the driver's air bag module connector in the arrow direction shown, and disconnect the connector.

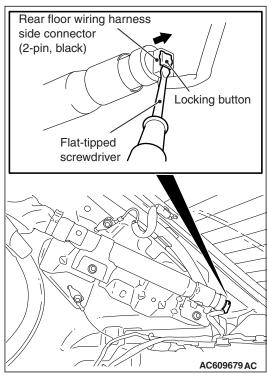
Use the flat-tipped screwdriver to pull out the locking button of rear floor harness side connector. After releasing the lock, disconnect the connector.

NOTE: If the curtain air bag module connector is disconnected from the rear floor wiring harness side connector, both electrodes of the curtain air bag module connector will be automatically shorted to prevent unintended deployment of the curtain air bag module due to static electricity, etc.
